Tributary Investigation: Ridley Creek Tributary (Glen Rd. and Brent Dr.)

Nether Providence Township
83250-115MS4

Tributary Investigation: Ridley Creek Tributary (Providence Road)

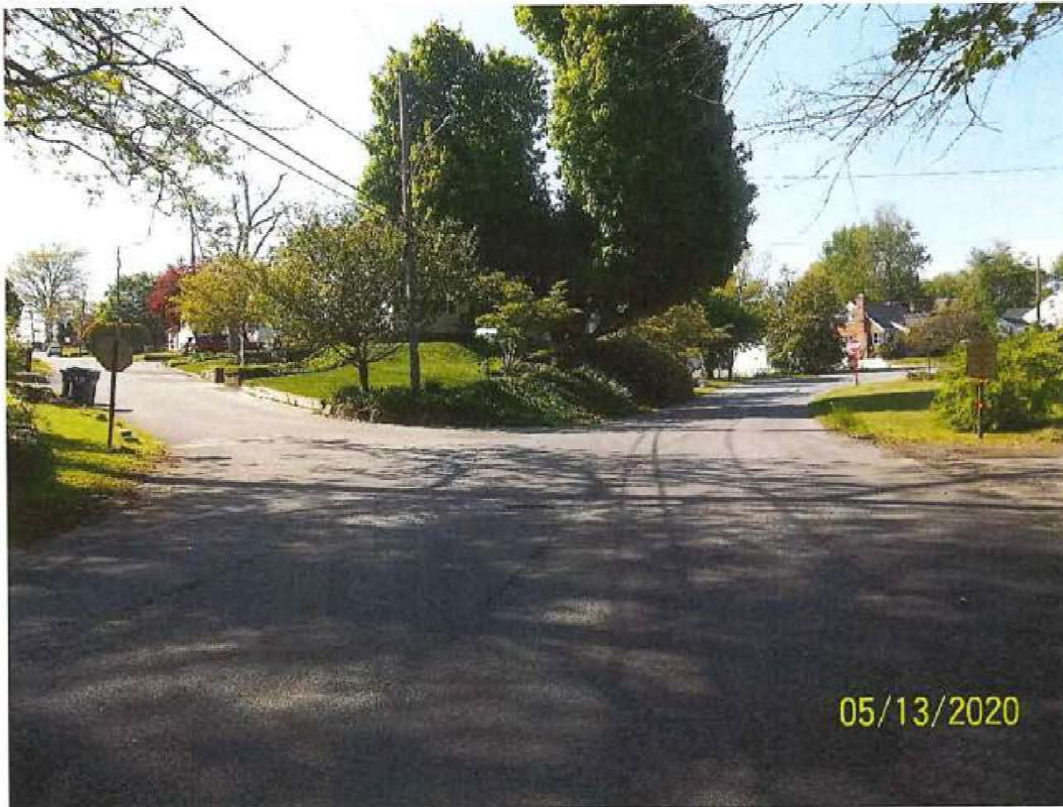
Figure 1. Maple Road and Harvey Road intersection.

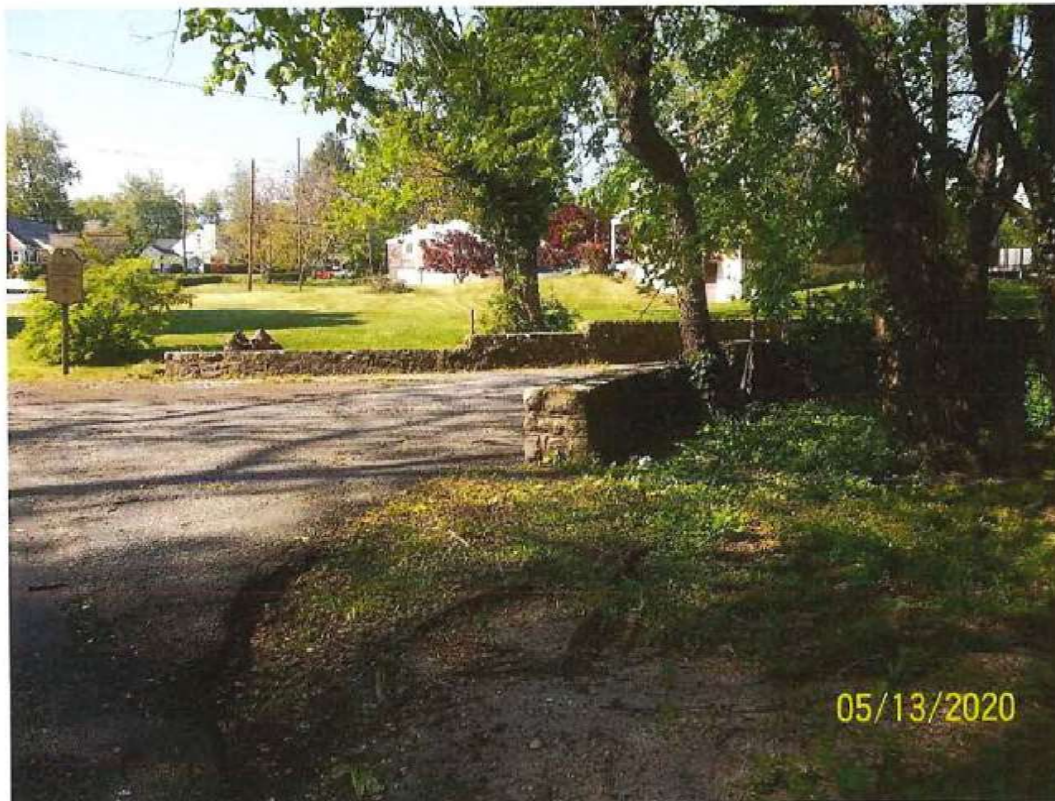
Figure 2. Driveway across from Maple Road. Beginning of Tributary.

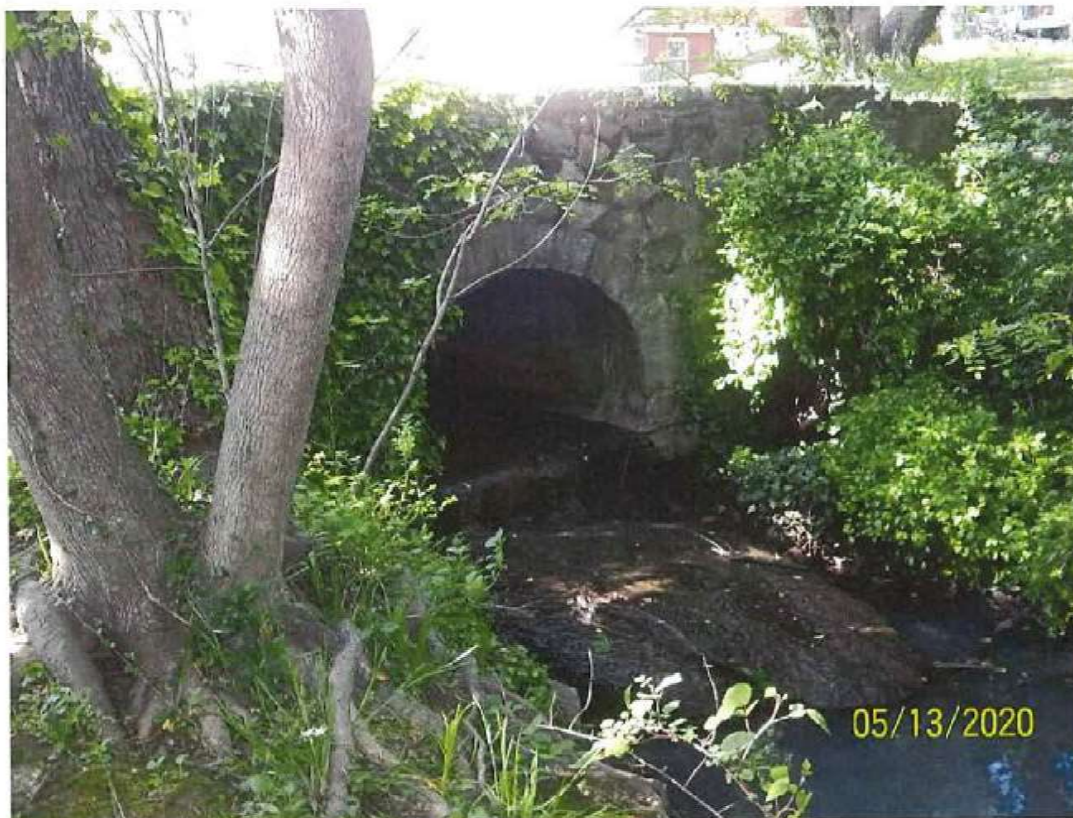
Figure 3. Culvert under driveway from Figure 2. Flow first observed here. Beginning of Tributary.

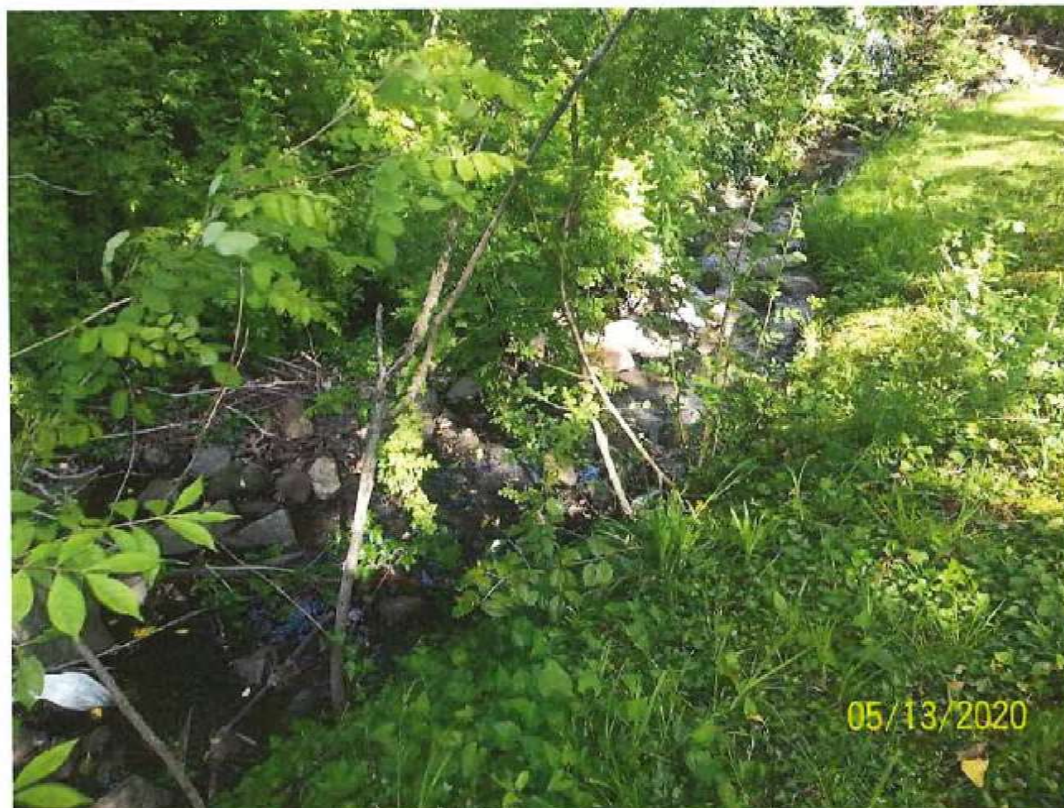
Figure 4. Stream just below culvert.

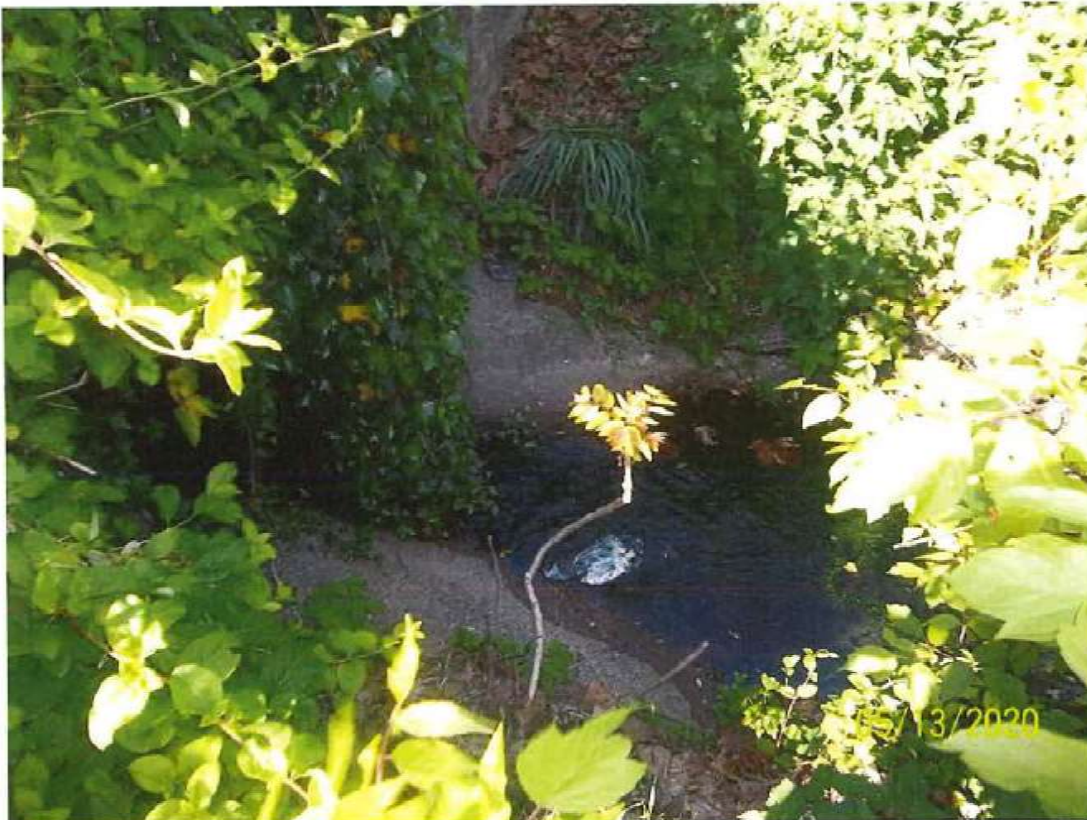
Figure 28. Tributary discharging into Ridley Creek.

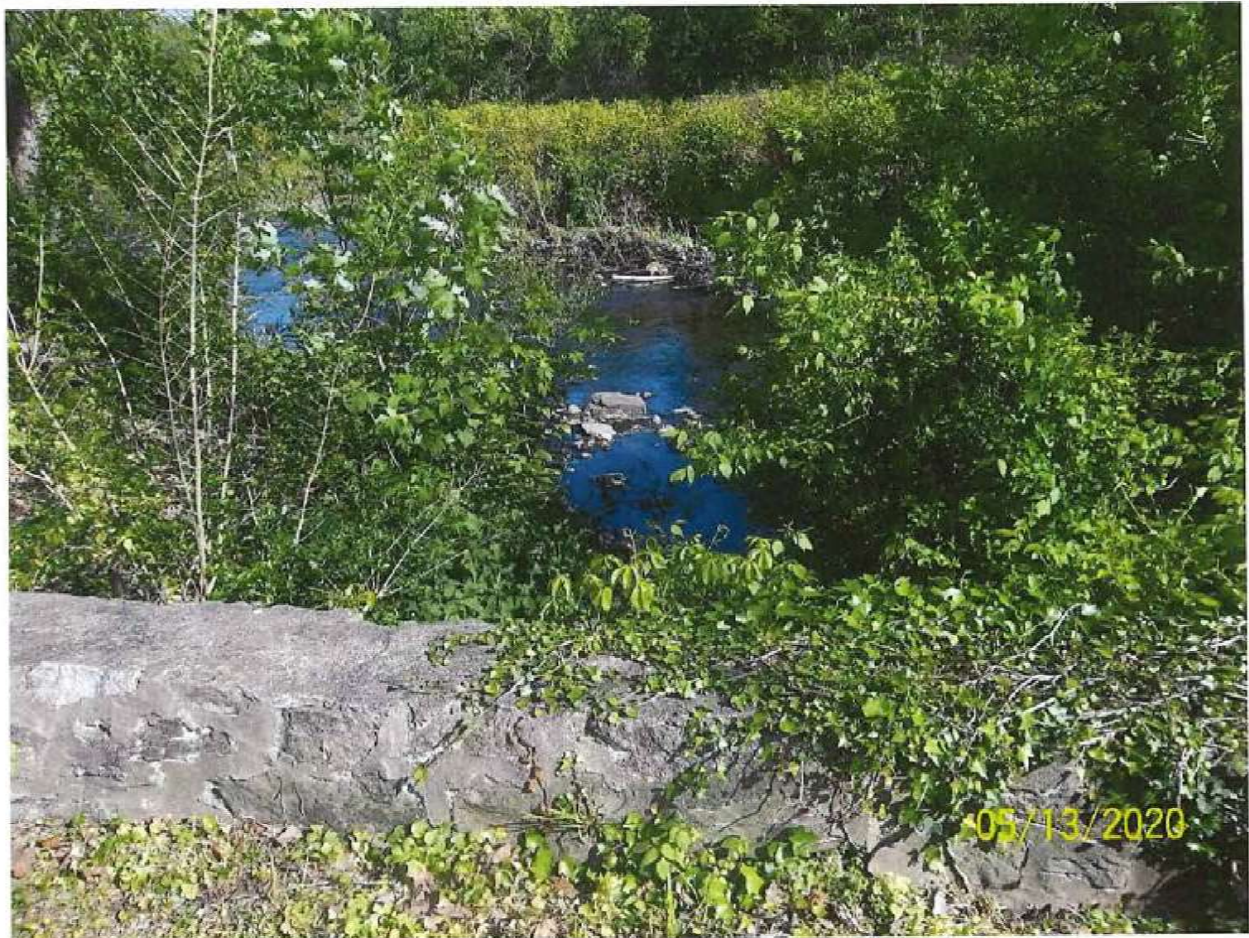
Figure 29. Top of culvert discharging to Ridley Creek on the other side.

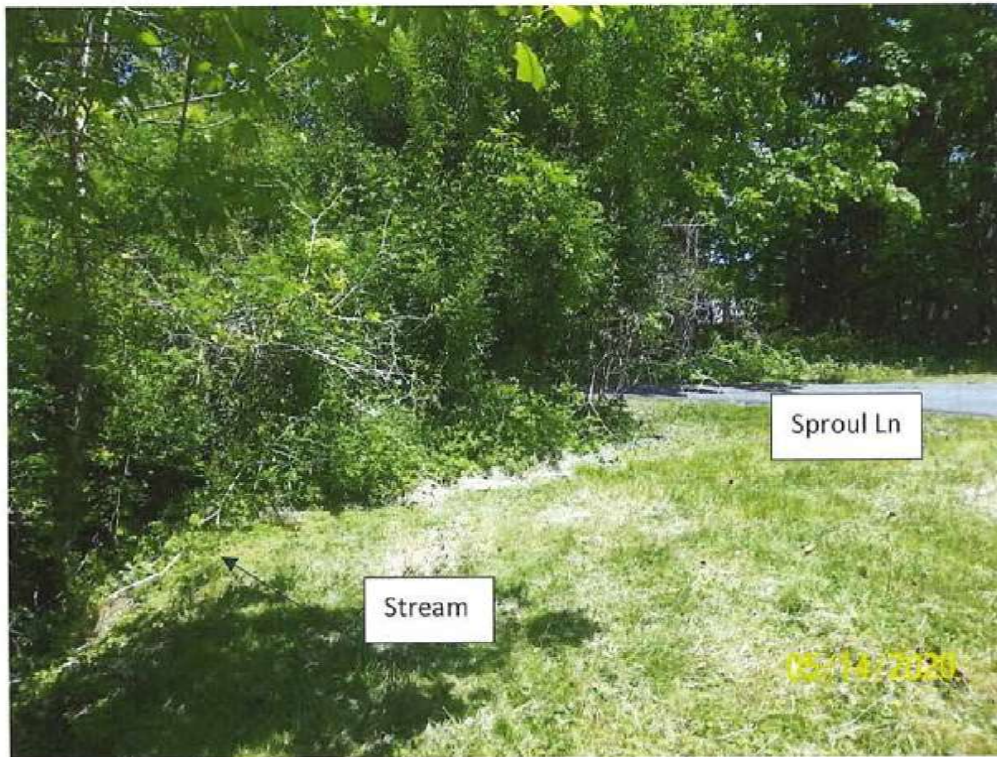
Figure 1. Top of Sproul Road on the Southern side. Flowing water first observed here. Beginning of tributary. Stream bed was dry before this point.

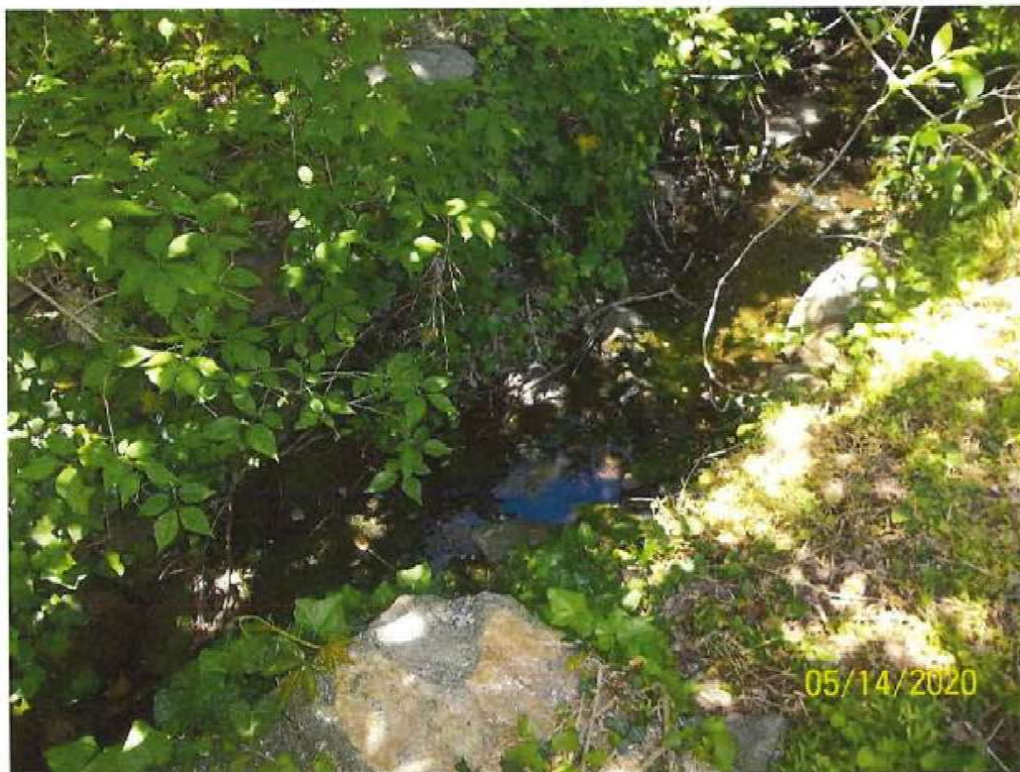
Figure 2. Flowing water at the beginning of tributary.

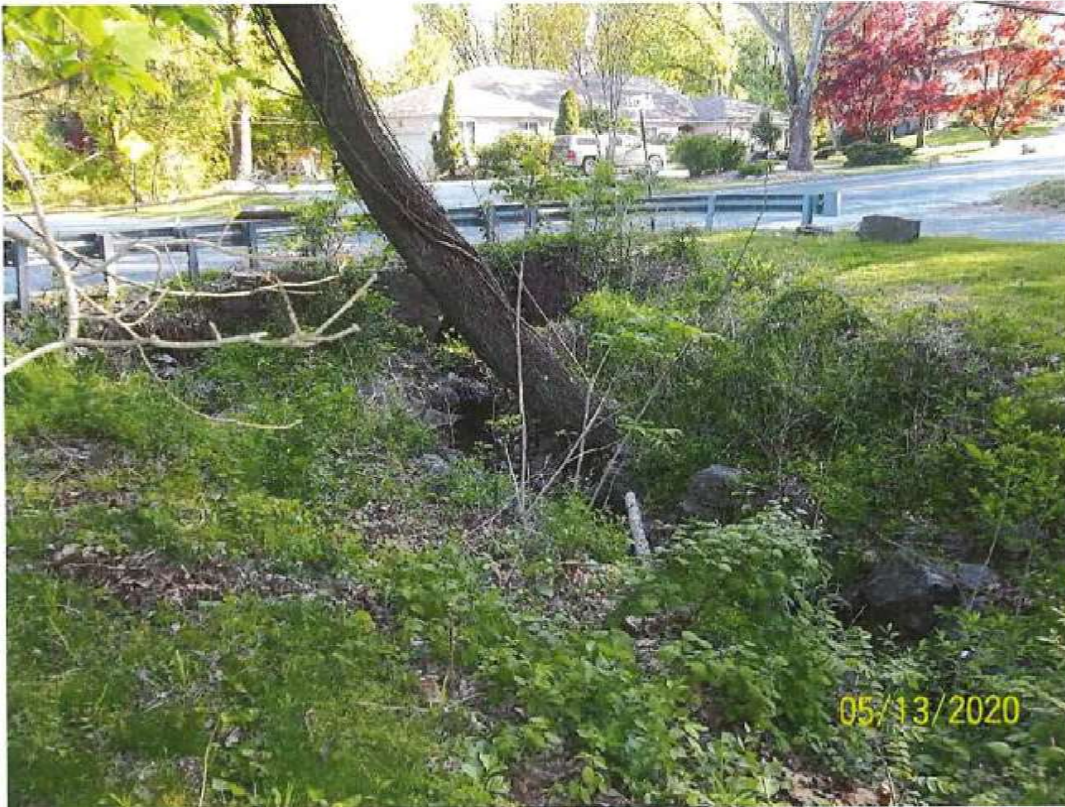
Figure 19. Tributary crossing Bullens Lane.

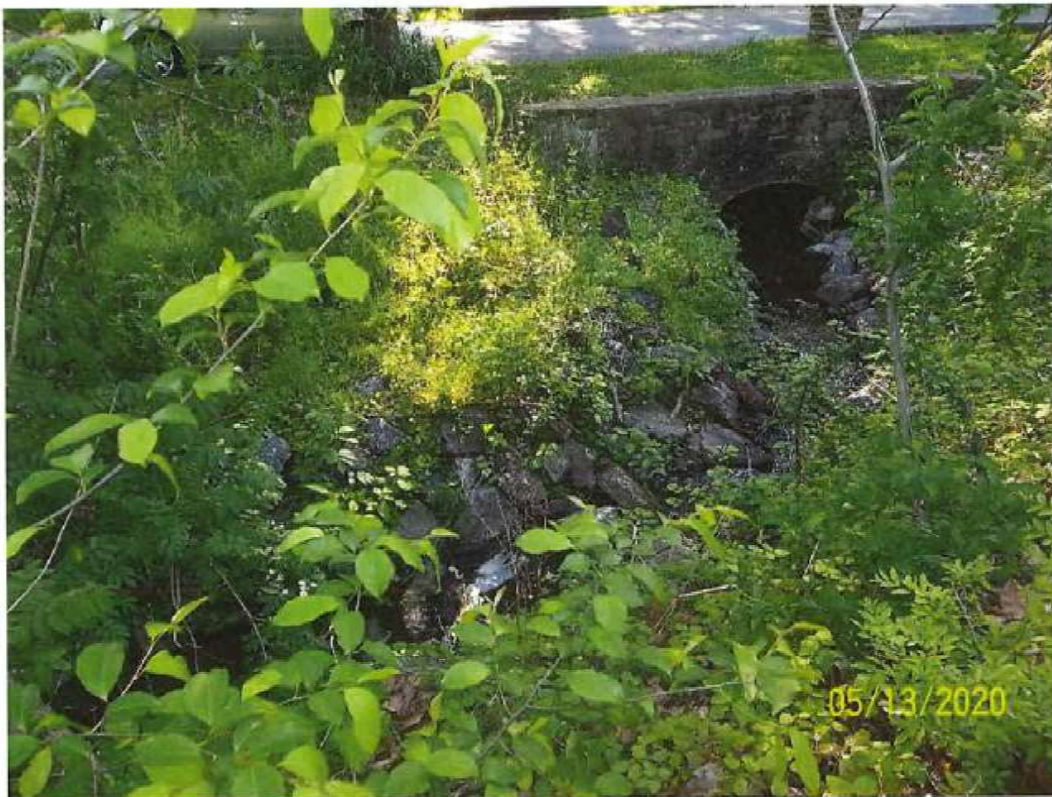
Figure 20. Closer image of culvert under Bullens Lane.

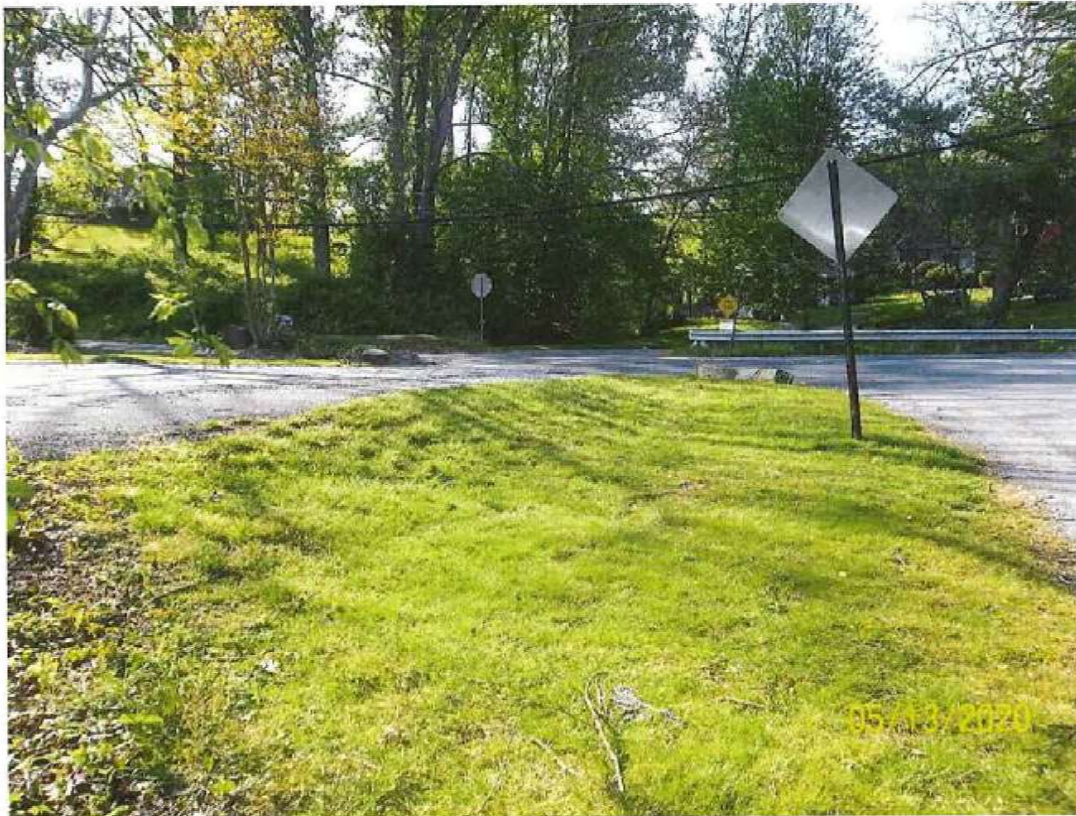
Figure 21. Bullens Lane and Glen Road intersection near where tributary resurfaces above ground.

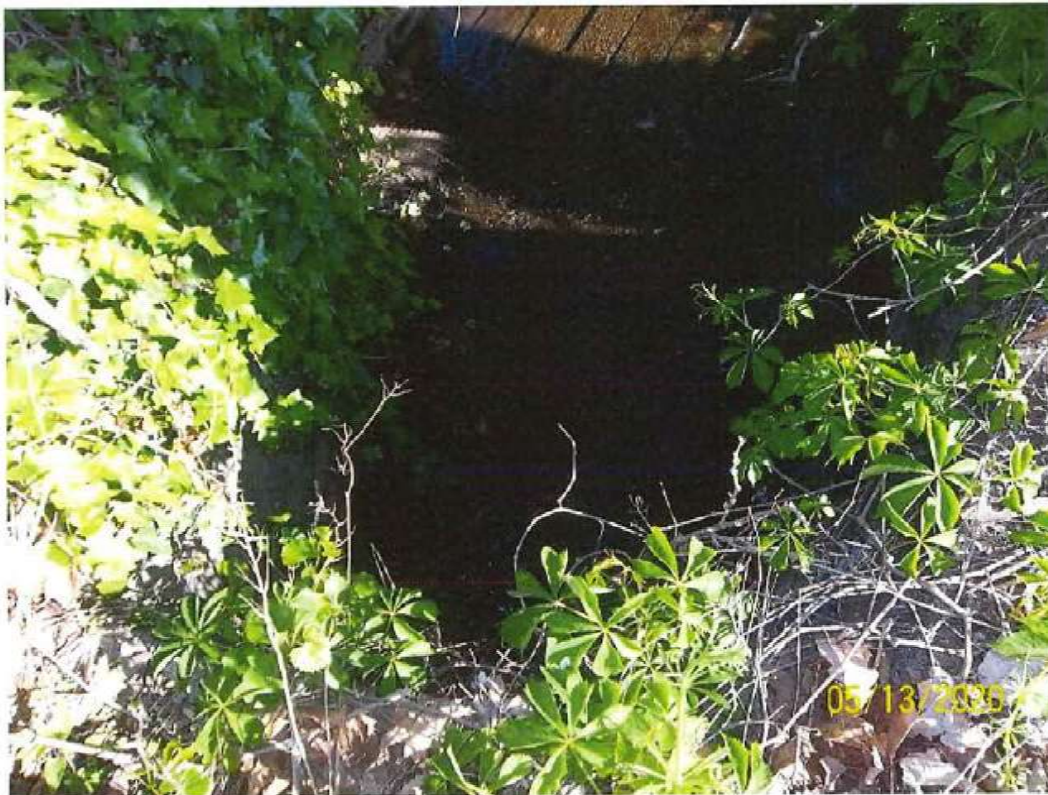
Figure 22. Other end of culvert where tributary resurfaces above ground.

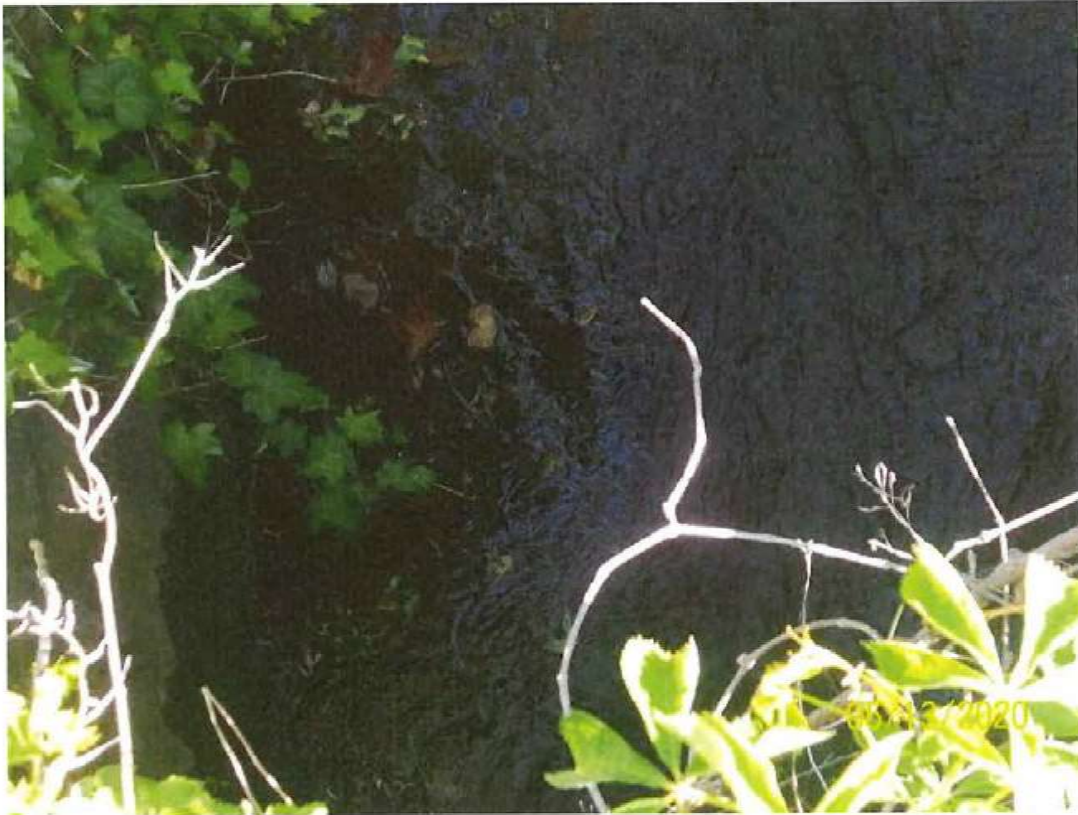
Figure 23. Water flowing out of culvert.

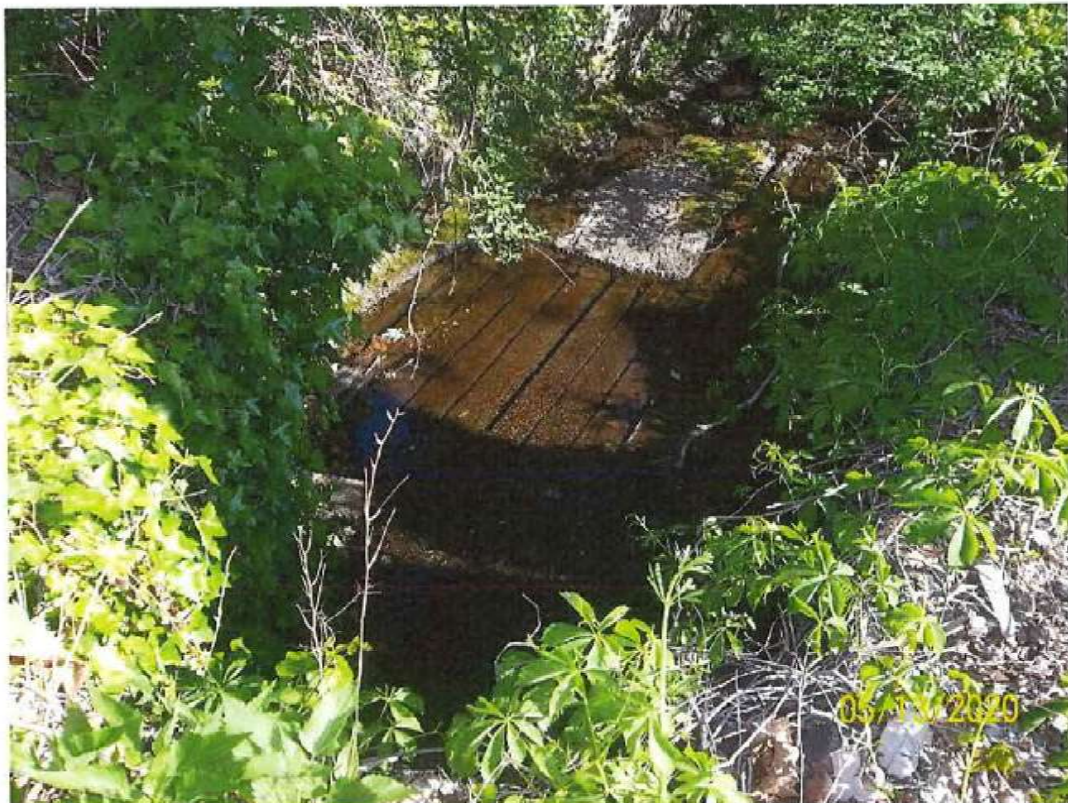
Figure 24. Water flowing out of culvert.

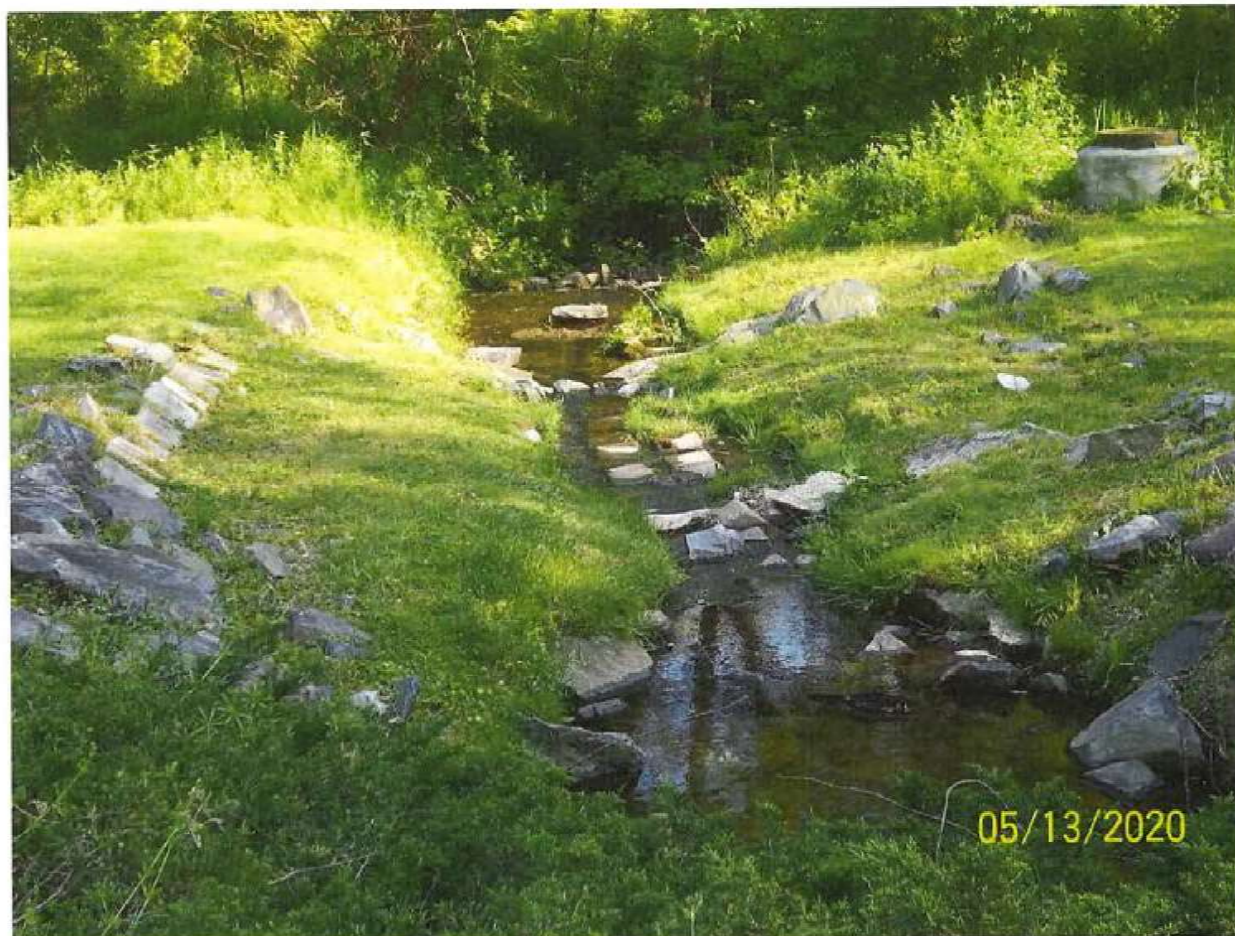
Figure 33. Tributary discharging to Ridley Creek.

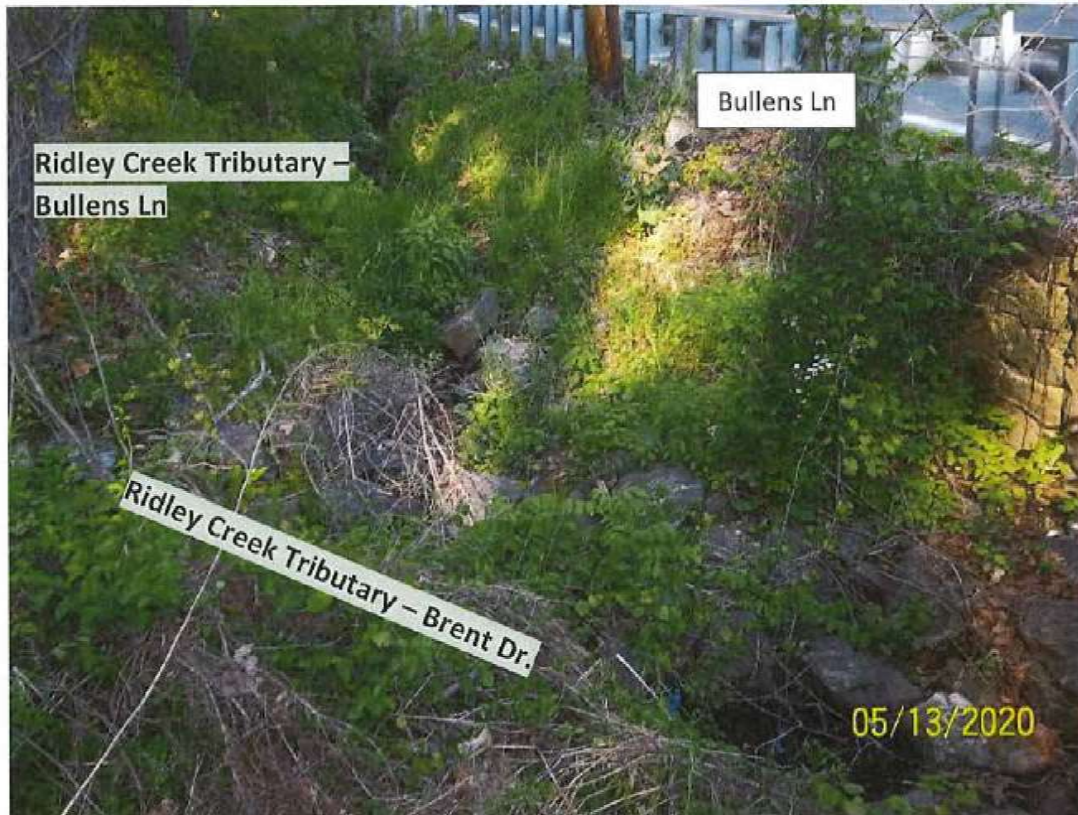
Figure 1. A second tributary (Bullens Lane) splits from the Ridley Creek tributary (Brent Drive) near the culvert.

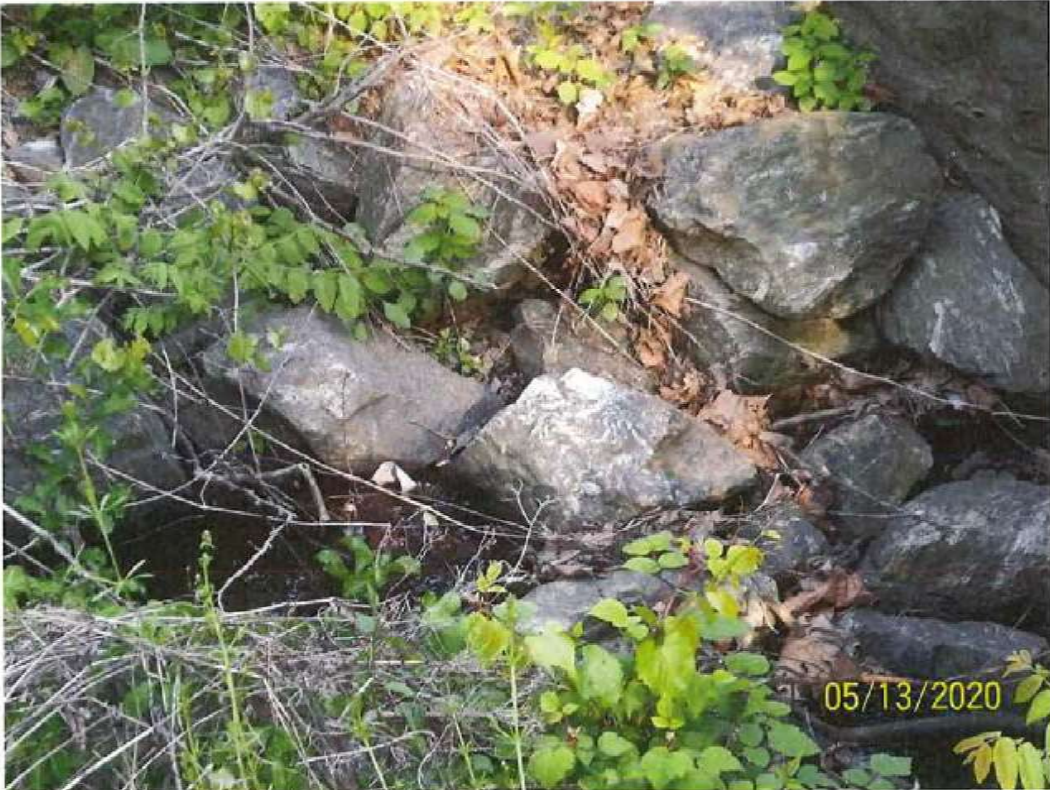
Figure 4. Flowing water observed.

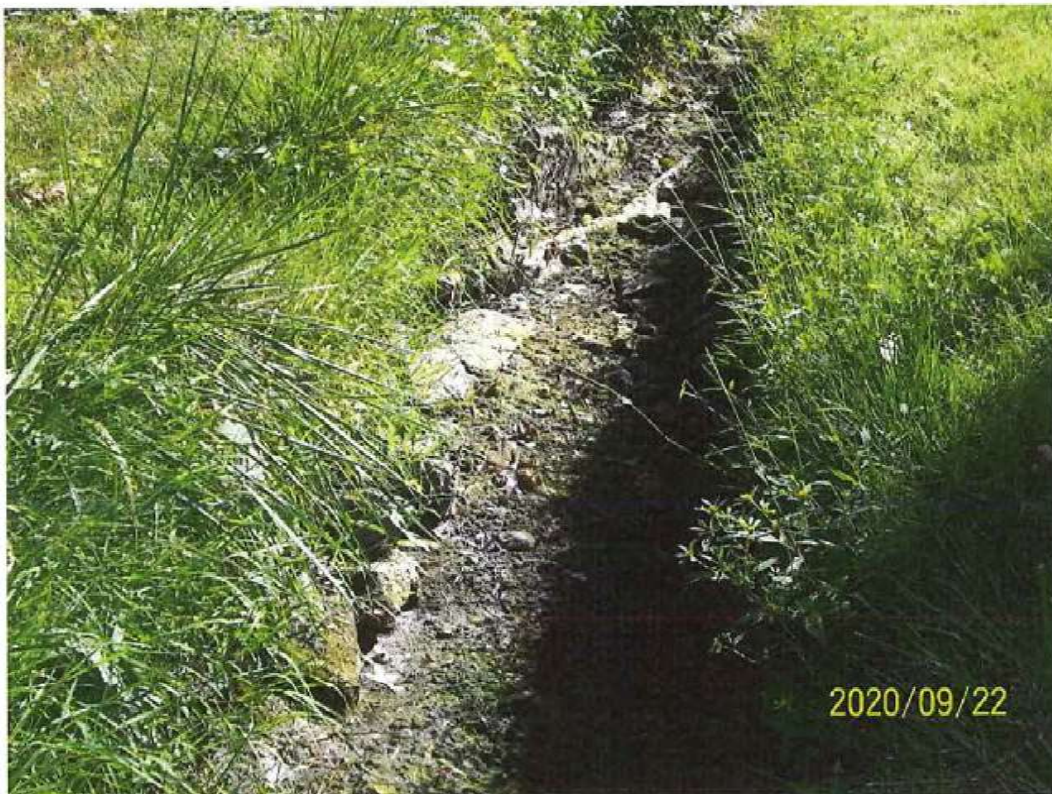
Figure 2. Dry Channel in the back of 418 Palmers Lane.

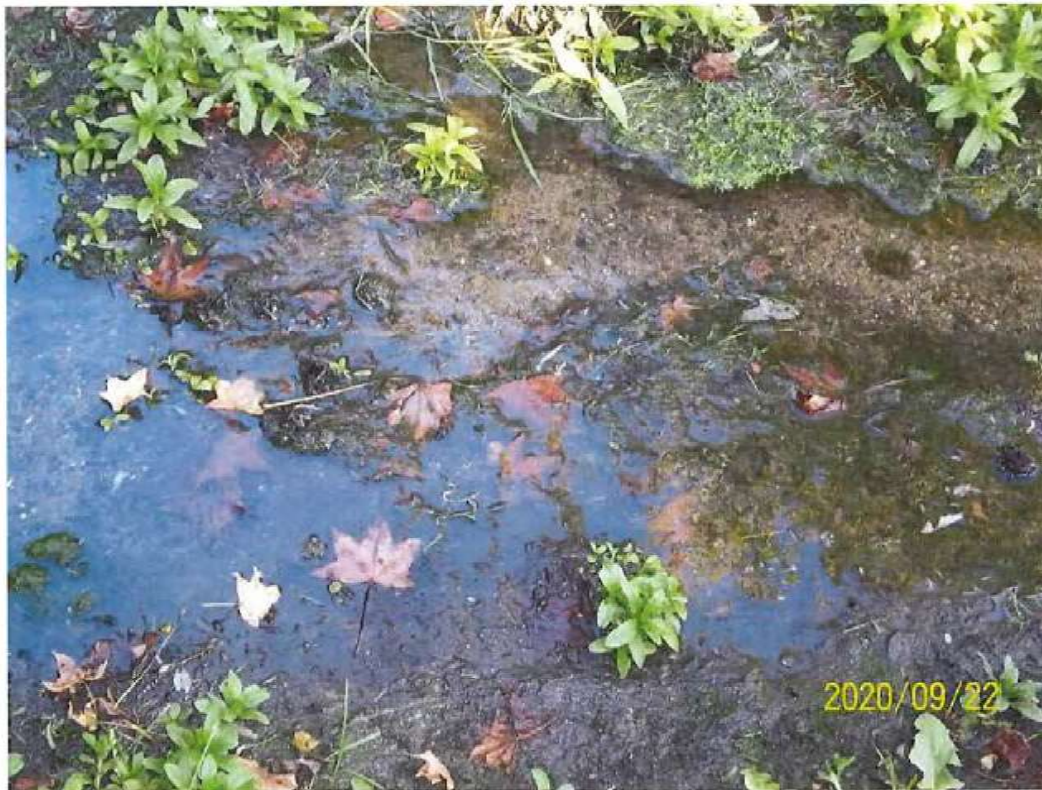
Figure 4. Flowing water observed.

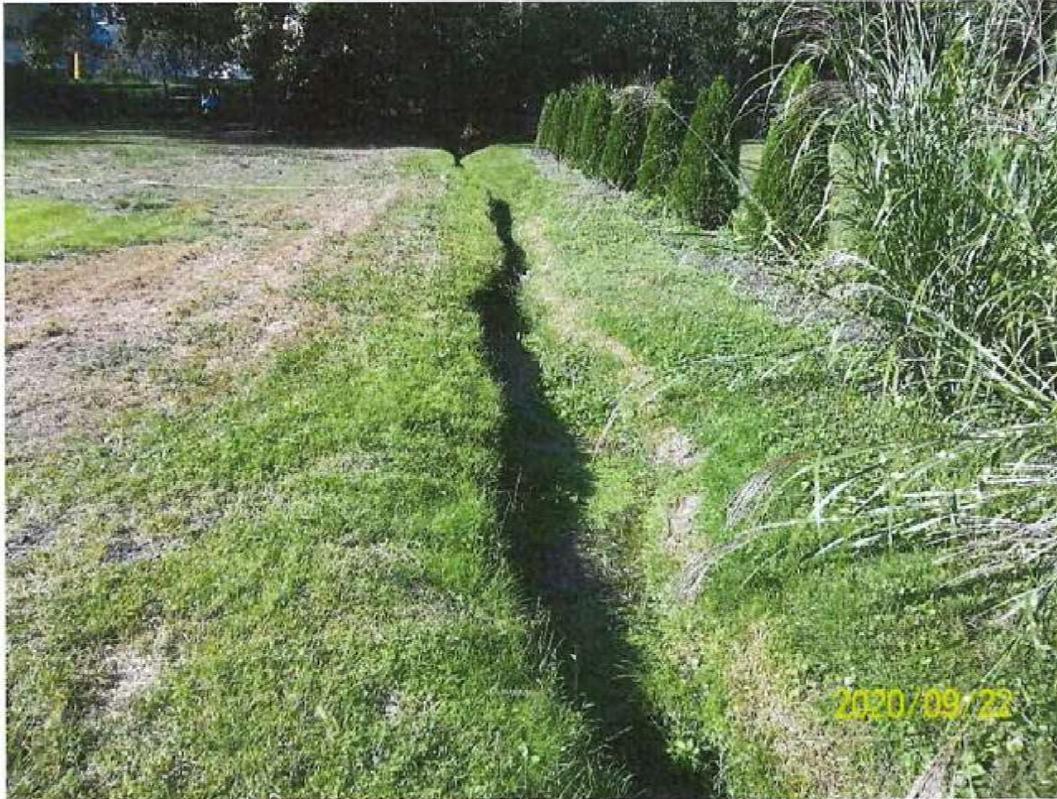
Figure 5. Just downstream of the beginning of the tributary. Flowing water observed. Lot of grass clippings in tributary.

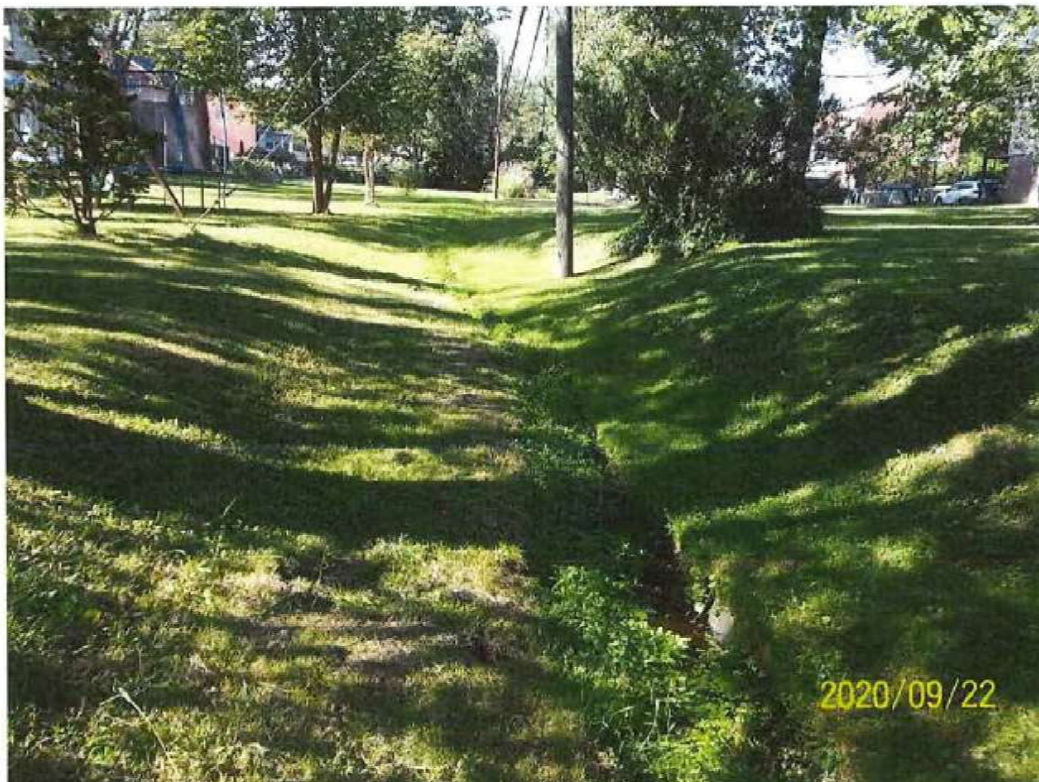
Figure 6. Photo of tributary in the backyard of 428 Palmers Lane looking towards beginning of tributary.

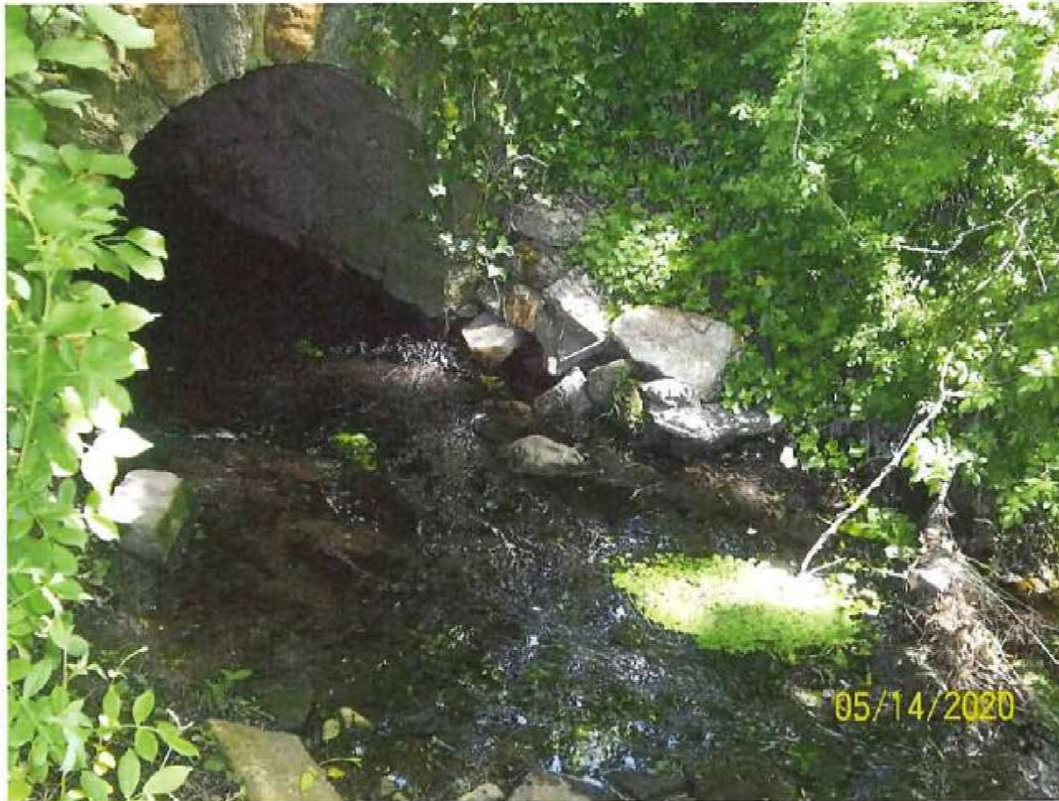
Figure 9. Culvert on the south side of E Rose Valley Road. Tributary continues.

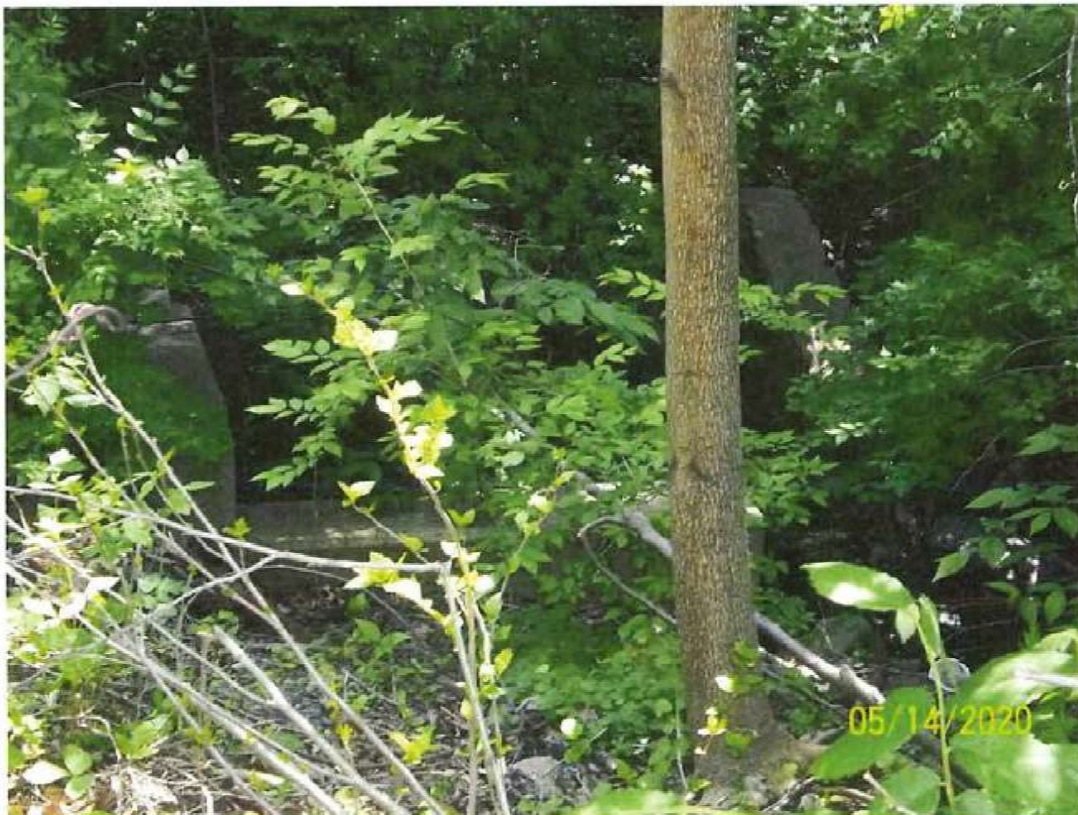
Figure 10. Side image of culvert.

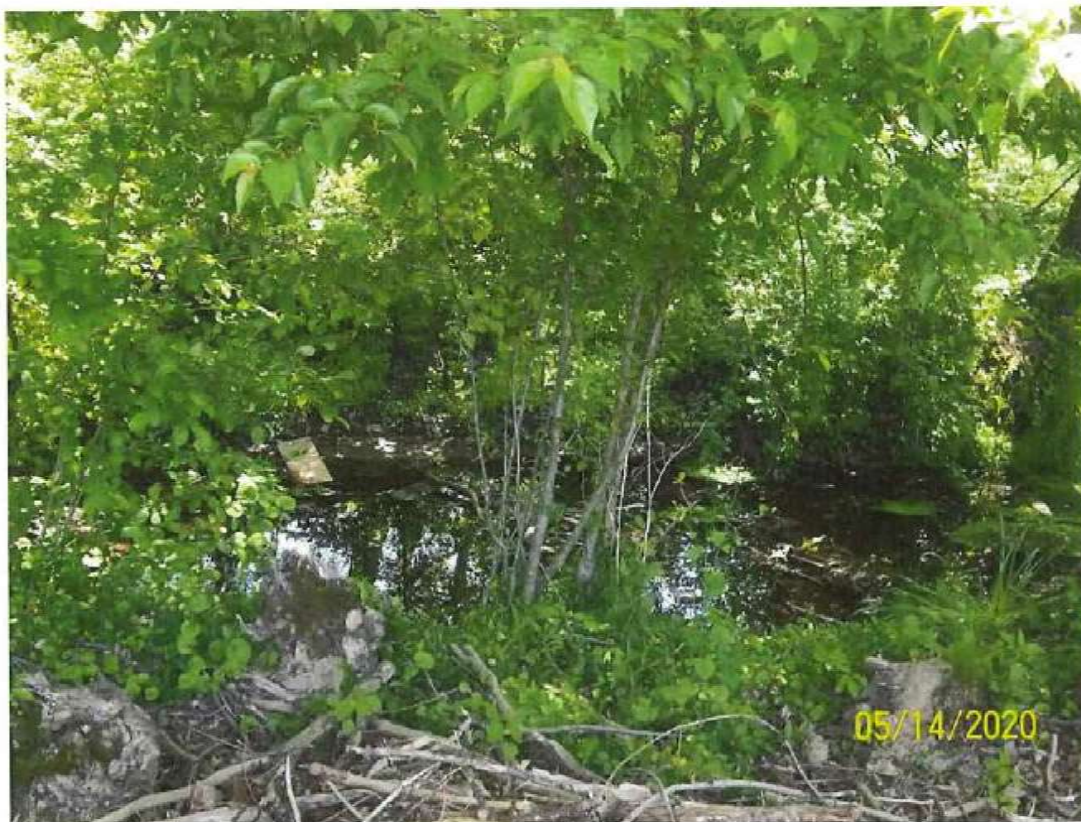
Figure 11. Stream just below culvert.

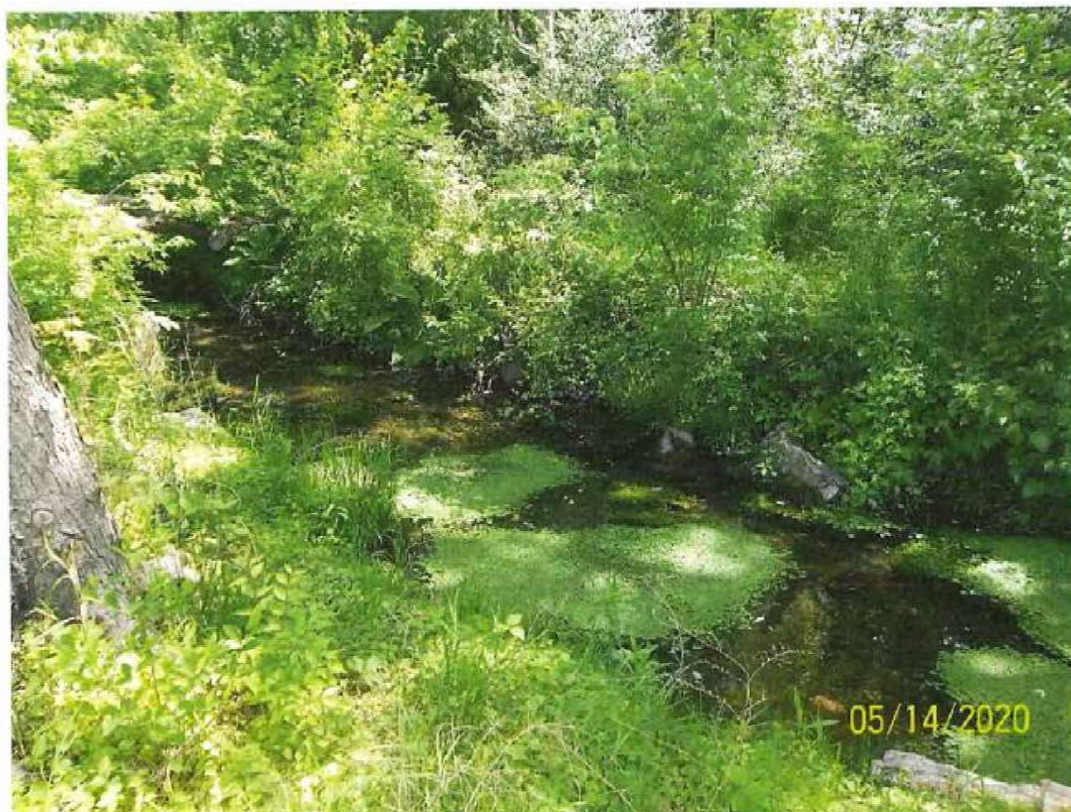
Figure 12. Stream just below culvert.
