Nether Providence Township and Swarthmore Borough, PA.

**Swarthmore Fire and Protection Association Station 14
South Media Fire Company Station 51
Garden City Fire Company Station 65**

Fire Apparatus Fleet Review and Assessment

March 2025

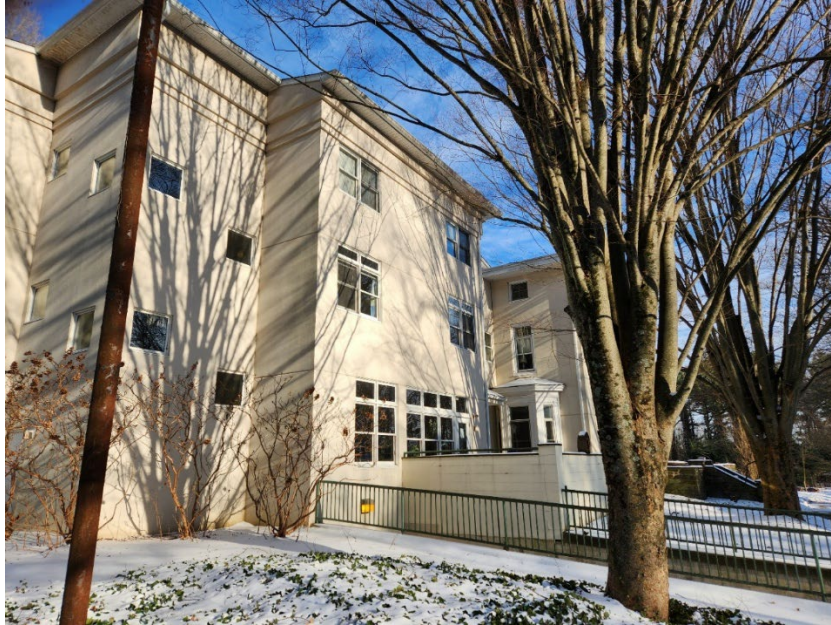
Firefighters trapped on the upper stories in this South Meida occupancy would have little chance of survival without multiple 35-foot portable ladders.

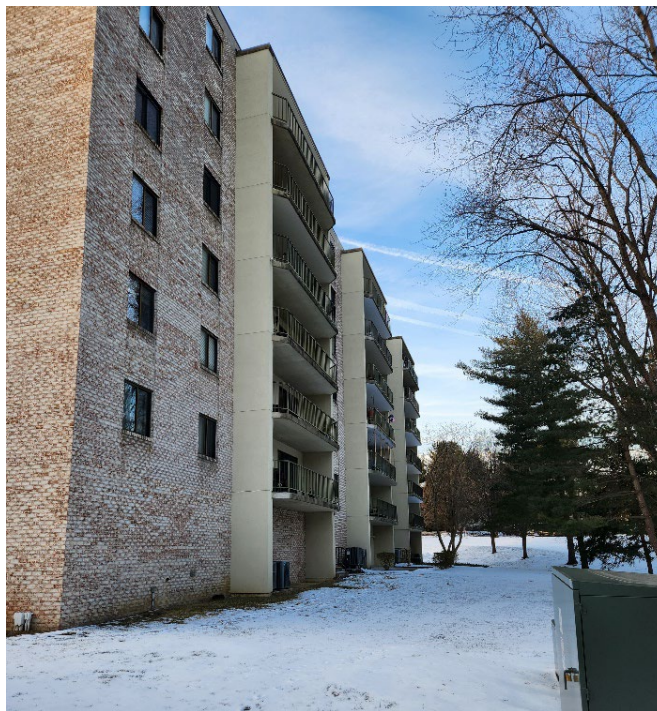
This apartment building in Garden City requires the services of multiple ladder companies outfitted with multiple 45-foot, 35-foot, and 28-foot portable ladders, as the building is only partially sprinklered.

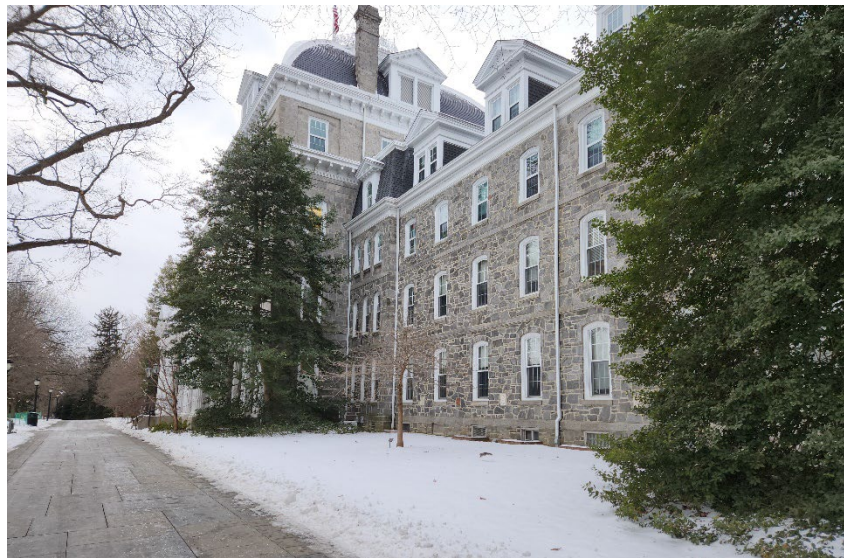
The lack of access at Swarthmore College for fire apparatus places a greater reliance on portable ladders and requires longer hose stretches.

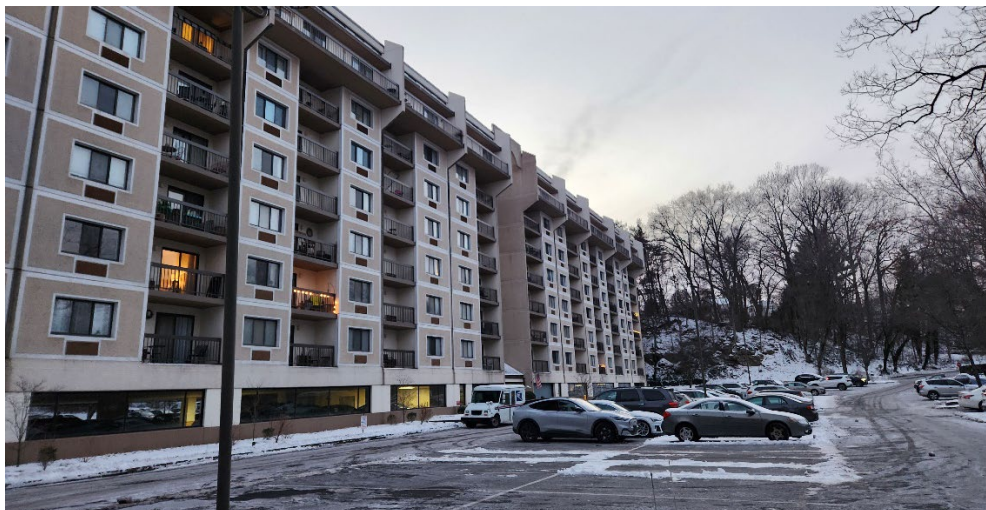
Aerial apparatus positioning can be problematic in several locations in the response area.

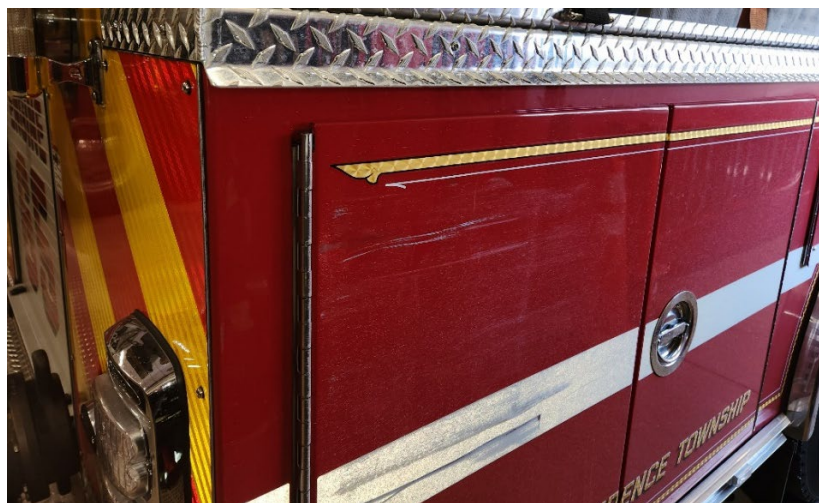
Repair the accident damage

5. The compartments should be cleaned, and all tools should be cleaned and repainted
6. All equipment on the vehicle should be mounted per NFPA 1900.
7. Accident damage should be repaired.

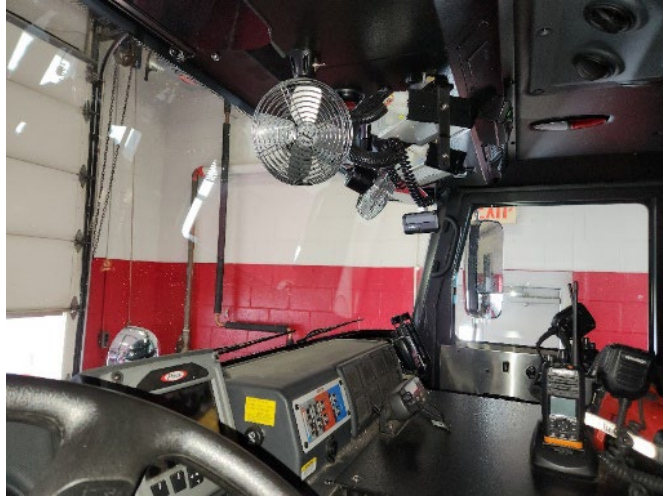
The driver's vision is partially obstructed.

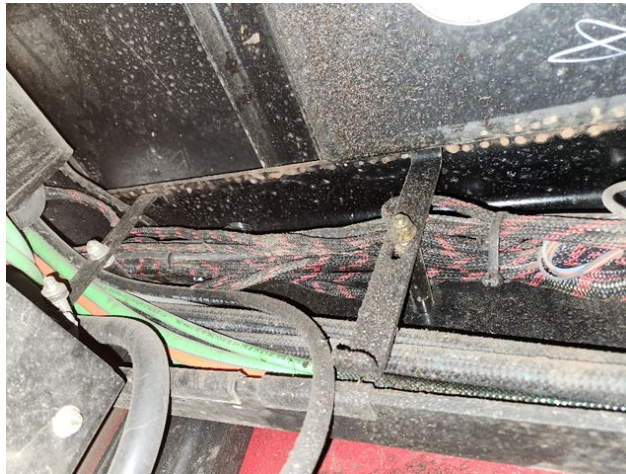
The underside of the apparatus should be steam cleaned and have a rust inhibitor applied.

1. The chassis frame rails, body substructure, and exposed fire pump components should be thoroughly steam cleaned with all exposed rust and corrosion removed. Minor rust and corrosion were noted in the frame rails battery boxes and air holding tanks which should be mitigated. The chassis steam cleaning should be conducted on at least an annual basis to remove accumulated dirt, road debris, and surface rust from the chassis and other components. At that point, the fire department should have a rust inhibitor like Krown or Carwell applied by an outside vendor.

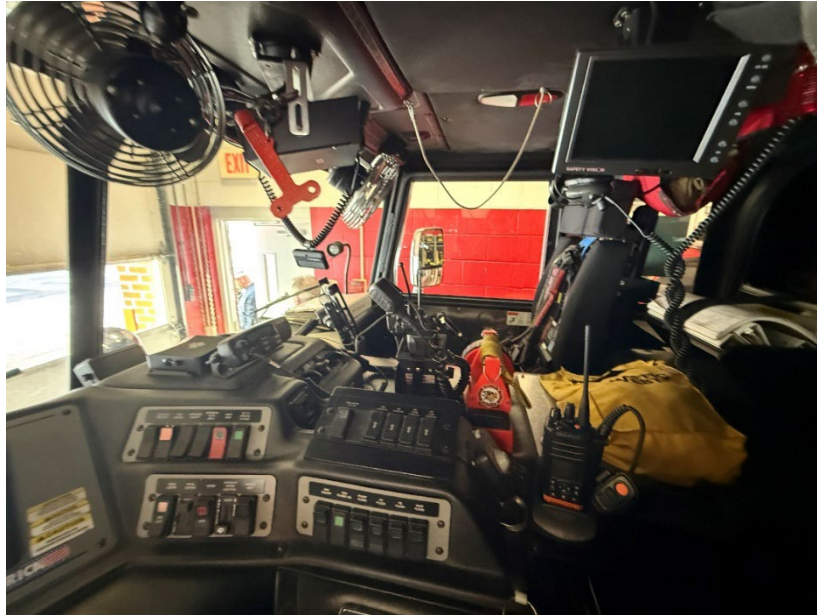
The Driver's view is badly obstructed. This needs to be mitigated in the next apparatus design.

12. The officer's and driver's seat cushions should be repaired or replaced.
13. The officer's and driver's seat belt needs to be replaced.
14. The Driver's view is obstructed and should be avoided on future apparatus purchases.

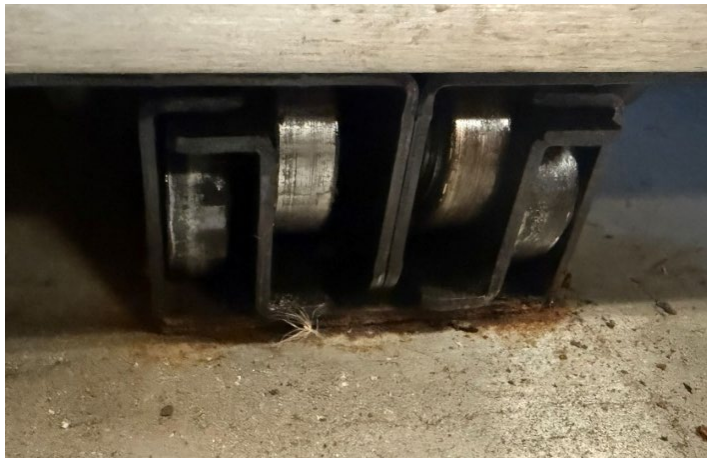
Initial corrosion on the bottom of this compartment due to dissimilar metals.

7. Heat sinks on portable ladders should be replaced and ladders tested.
8. All dissimilar metals must be isolated to prevent rust and corrosion.
9. All equipment carried inside the cab should be restrained and mounted in 9G certified brackets per NFPA 1900.

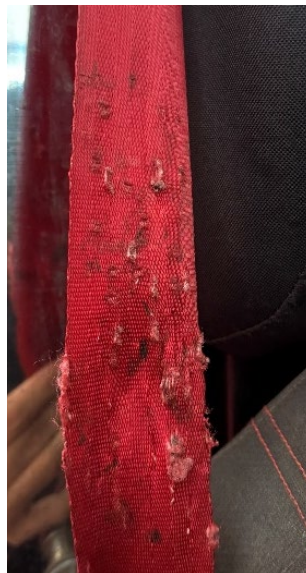
The officer's seatbelt needs to be replaced.

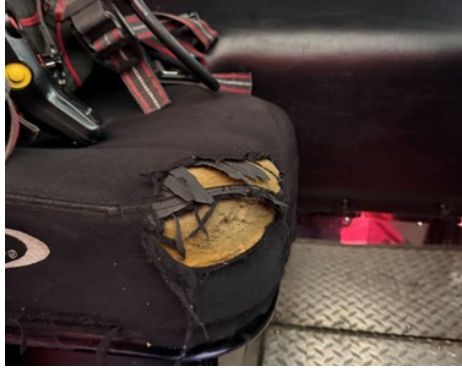
Officers' seat cushions need to be repaired or replaced.

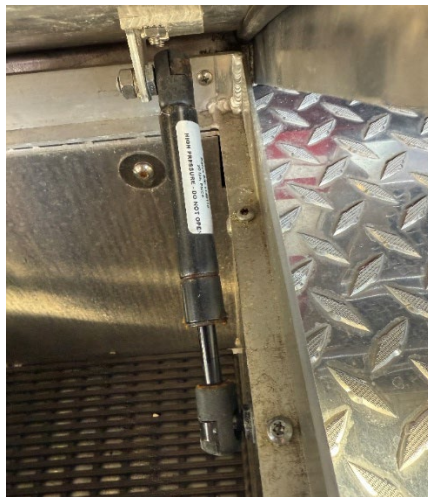
Gas Shocks on the front bumper compartment cover need to be replaced.

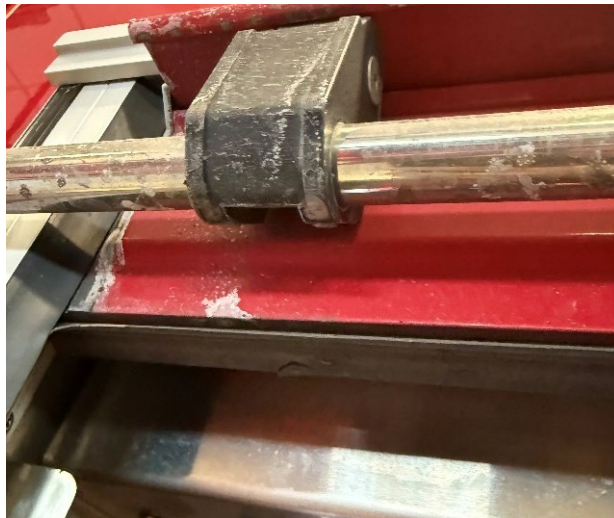
Roll-up door gaskets should be replaced to prevent dirt and moisture in the compartments.

10. All nozzles should be tested annually.
11. The alignment of all doors should be checked and maintained, and the seals on the roll-up doors should be replaced as needed. Additionally, the lap doors should be inspected and maintained regularly.

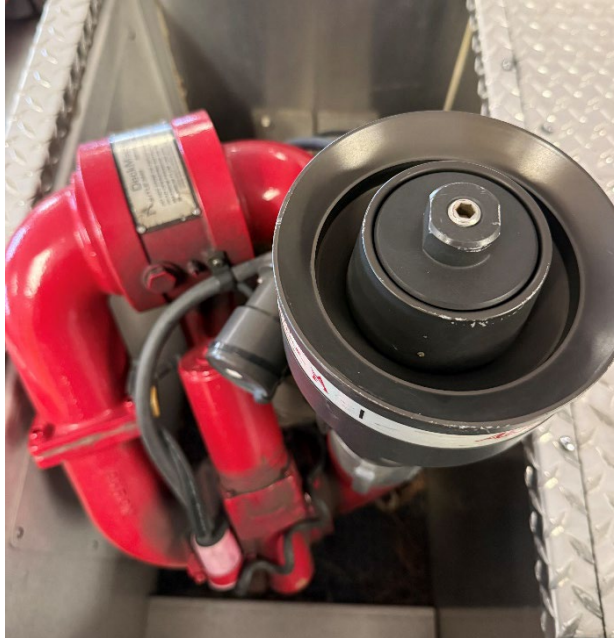
This nozzle needs to be replaced with a set of smoothbore stacked tips.

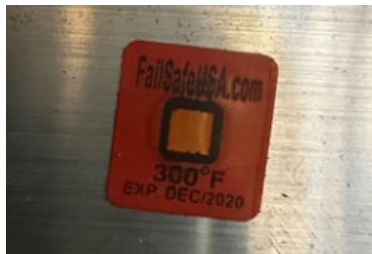
The heat sinks on the portable ladders are out of date and have expired.

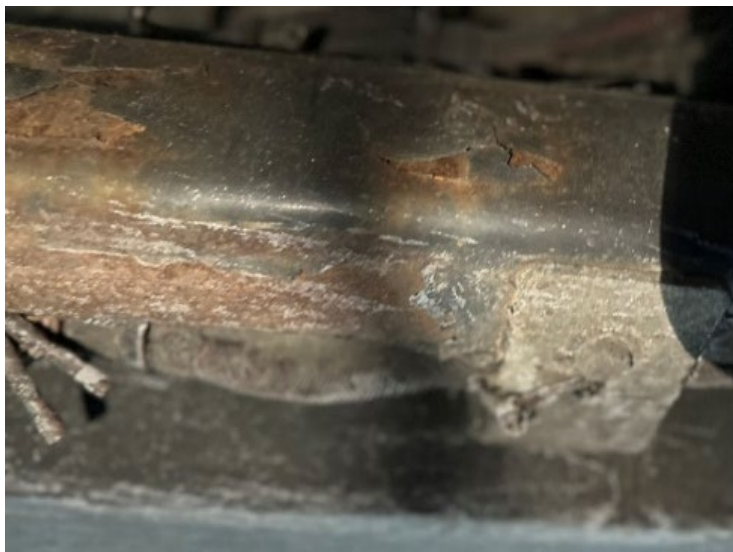
Surface rust on frame rails needs to be mitigated.

1. The chassis frame rails, body substructure, and exposed fire pump components should be thoroughly steam cleaned, with all exposed rust and corrosion removed. Moderate rust and corrosion were noted in the frame rails, battery boxes, and air-holding tanks, which should be addressed. The chassis should be steam cleaned annually to remove accumulated dirt, road debris, and surface rust from the chassis and other components. At that point, the fire department should have a rust inhibitor like Krown or Carwell applied by an outside vendor.

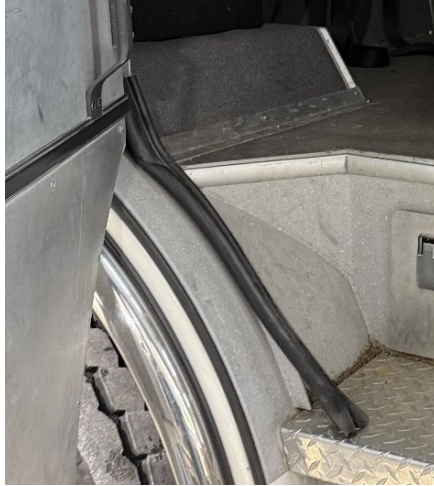
Replace or repair door rubber gaskets that are damaged.

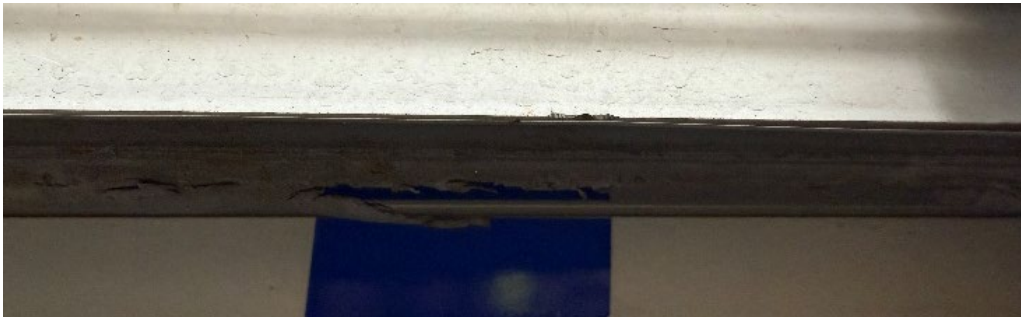
Replace all rollup door rubber gaskets.

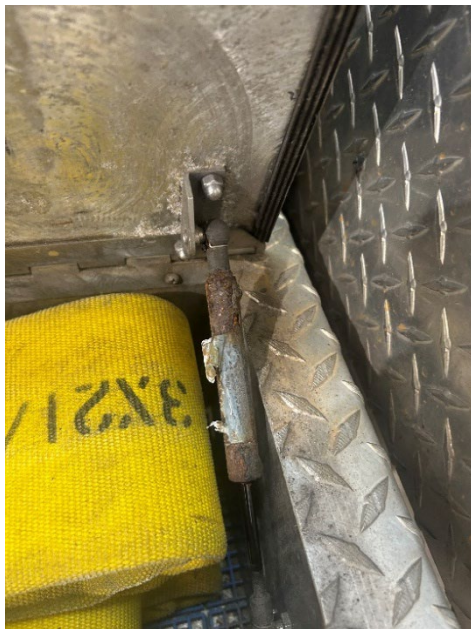
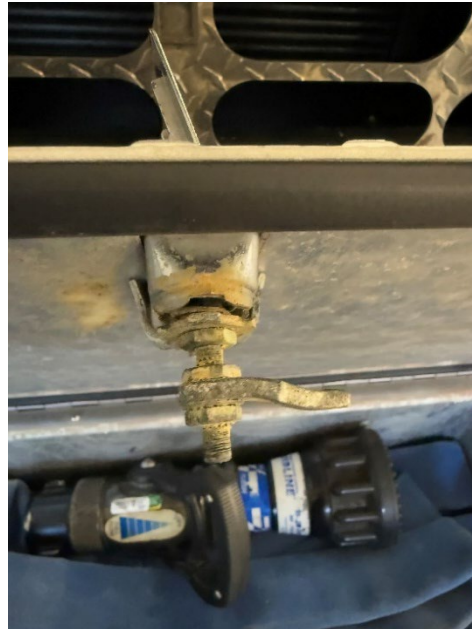
All corroded latches and corroded gas struts need to be replaced.

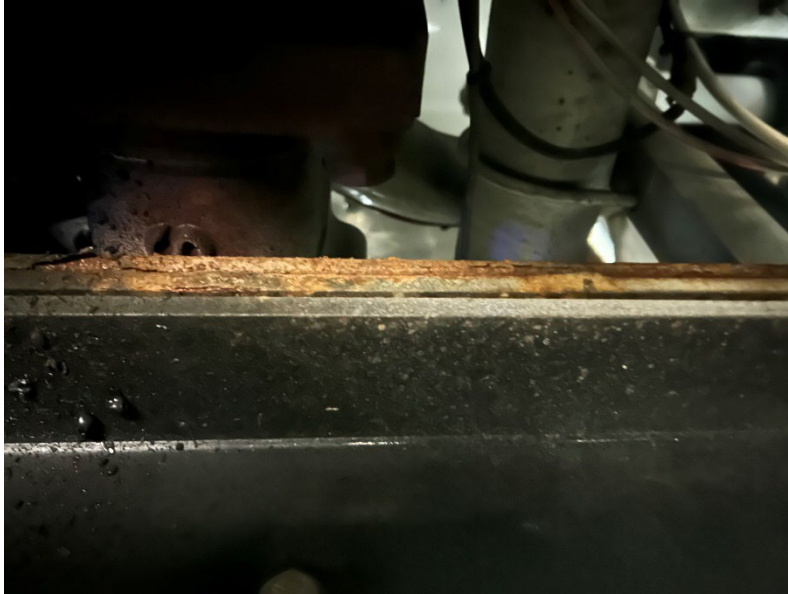
Corrosion on the officer's side frame rails needs to be mitigated as the frame rails are starting to fracture.

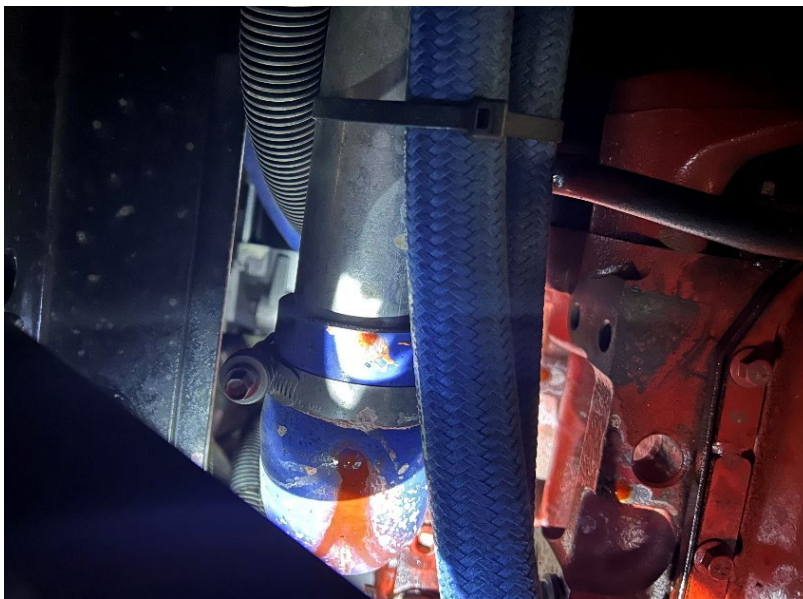
Repair coolant leak

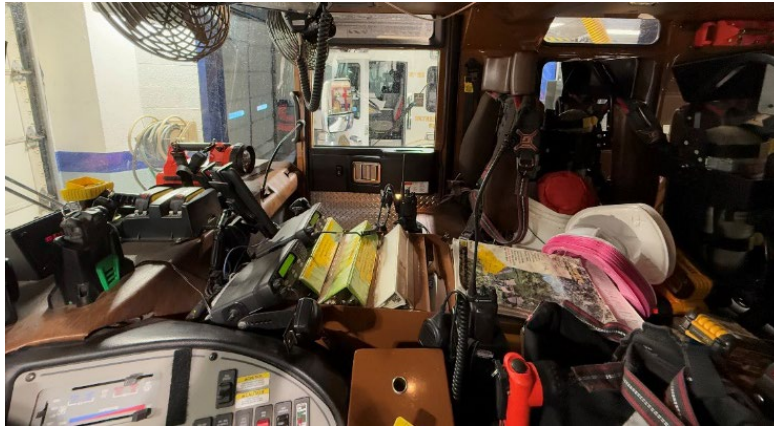
All equipment in the cab must be secured with NFPA 9G brackets.

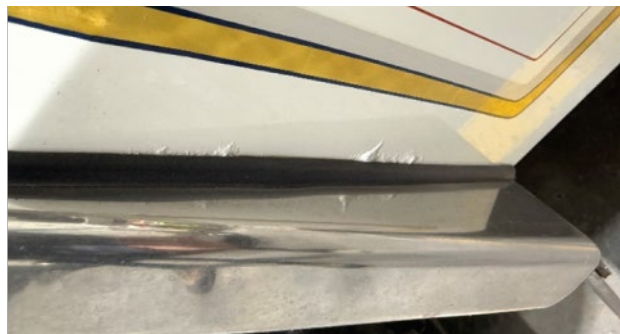
Exterior corrosion should be mitigated.

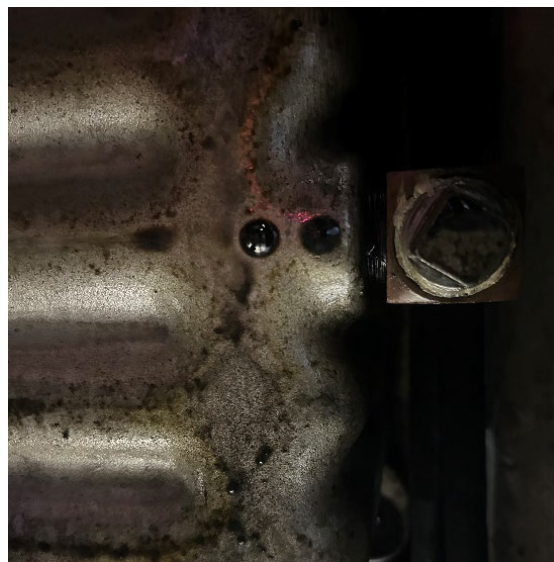
Oil leaks need to be repaired.

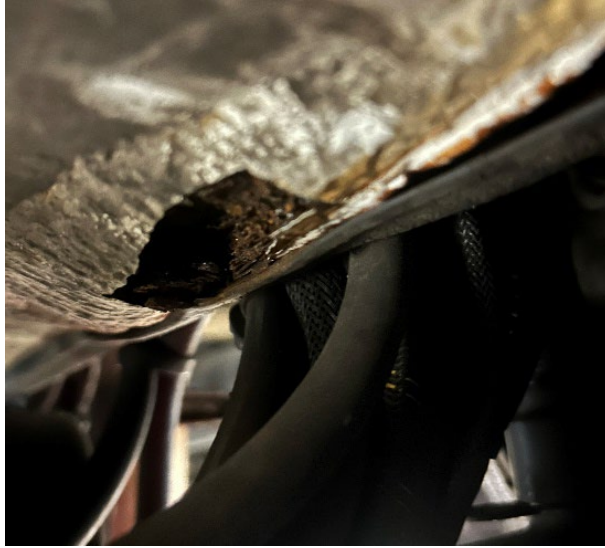
Major rust and corrosion must be evaluated and repaired.

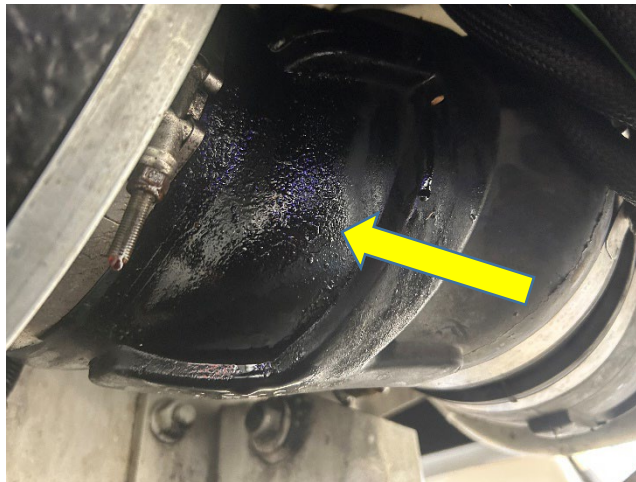
The coolant leak needs to be repaired.

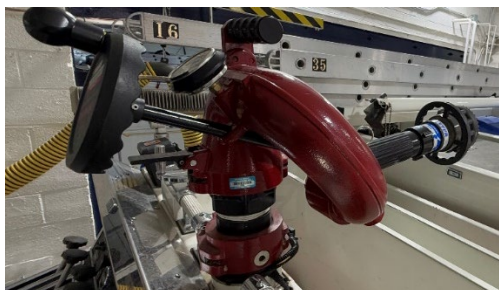
Replace the combination nozzle with a set of stacked tips with a smoothbore and a stream shaper to achieve reach and penetration of the stream.

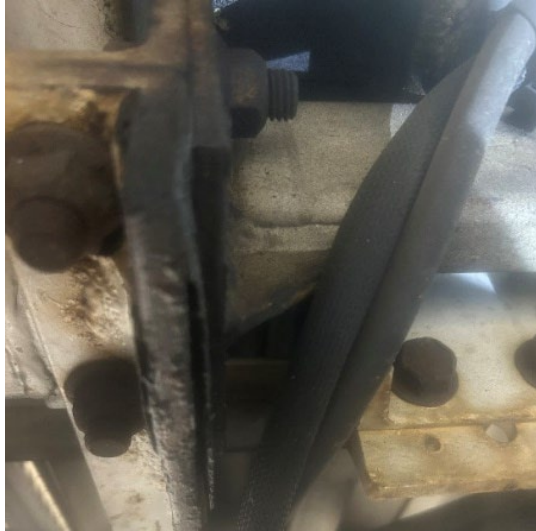
The moderate rust needs to be mitigated before it gets worse.

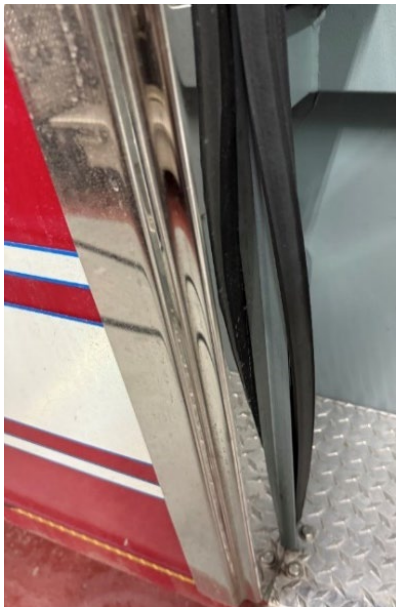
The door gasket needs to be repaired or replaced.

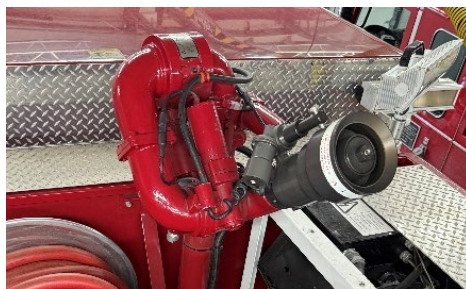
Replace the fog nozzle on the master stream with a set of stacked tips and a stream shaper to achieve full flow, thereby increasing reach and penetration of the stream.

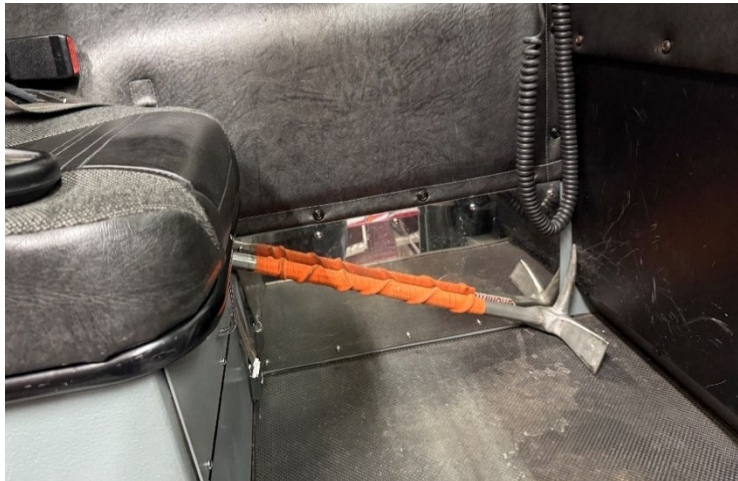
All tools in the cab should be restrained in a 9G rated bracket. In the event of an apparatus rollover, this Halligan can become a lethal projectile.

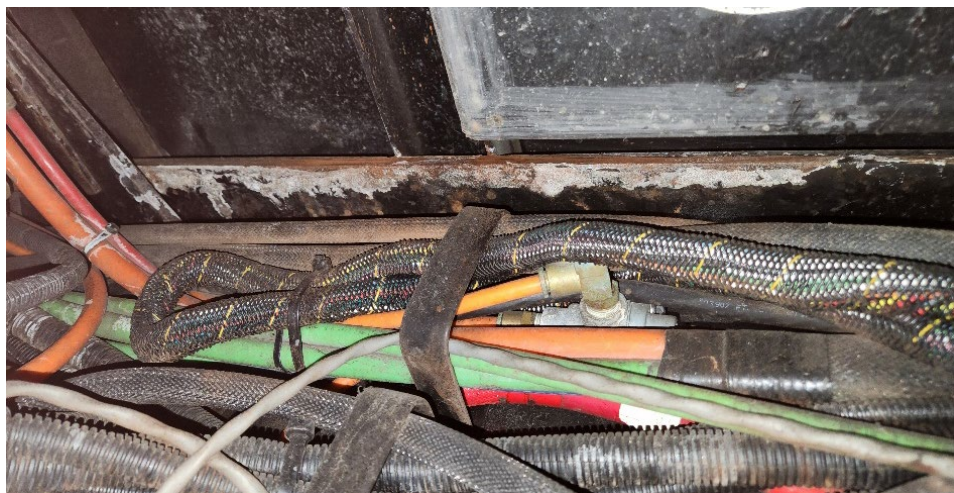
Corrosion on the frame rails needs to be mitigated.

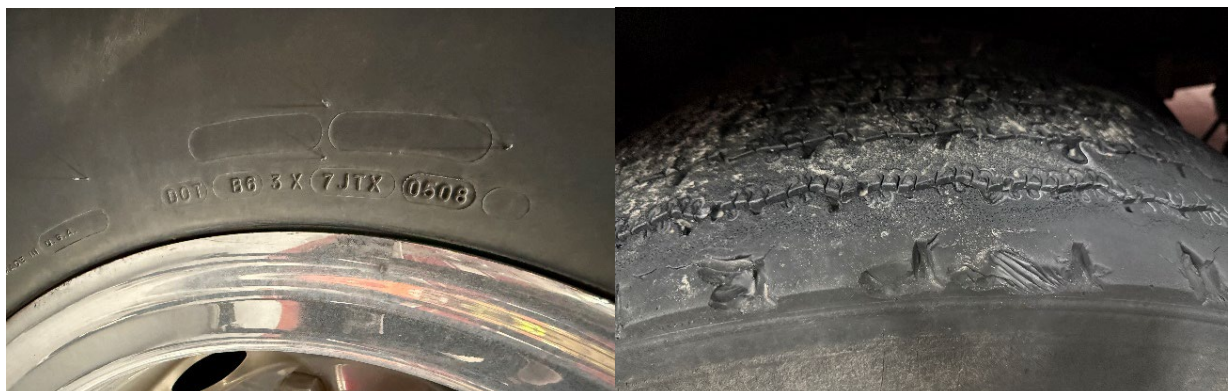
This tire is one of five that are original equipment and well beyond the seven-year NFPA 1910 allowance. All six tires need to be replaced immediately.

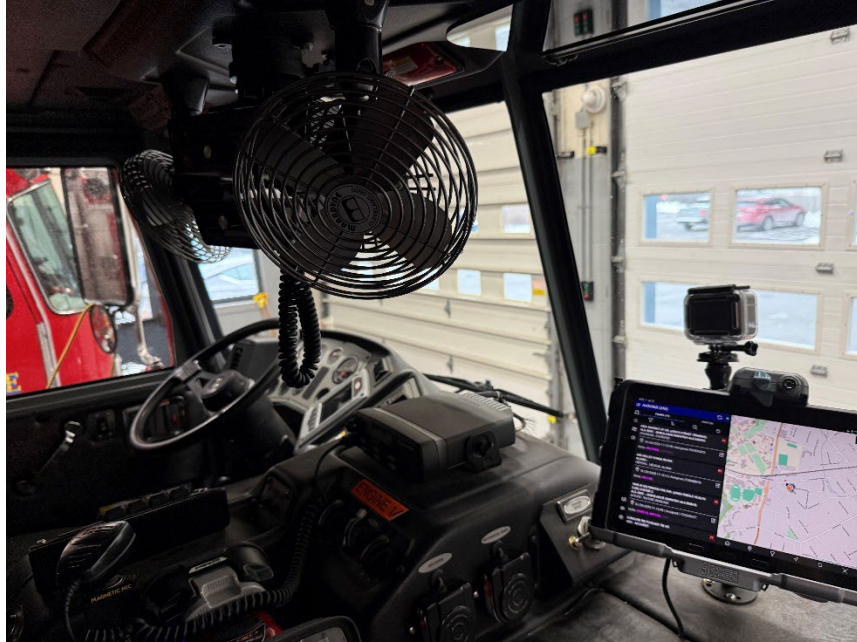
The driver has poor visibility outside of the front windshield and the officer's side mirror.

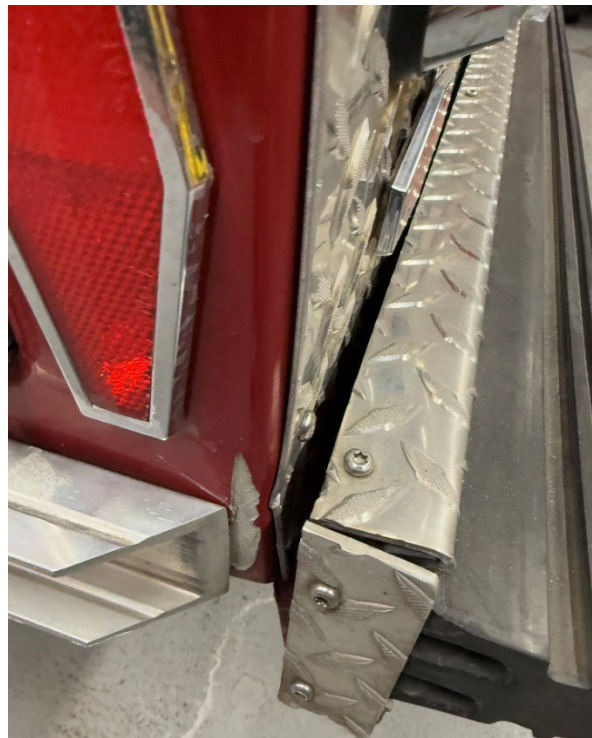
Repair the accident damage before it starts to corrode.

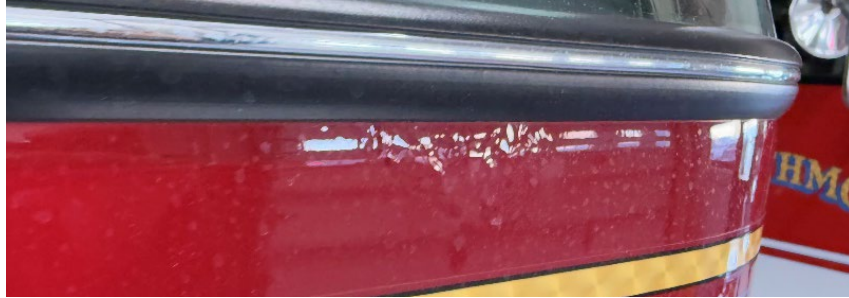
Bubbling paint and corrosion need to be mitigated under the front windshield.

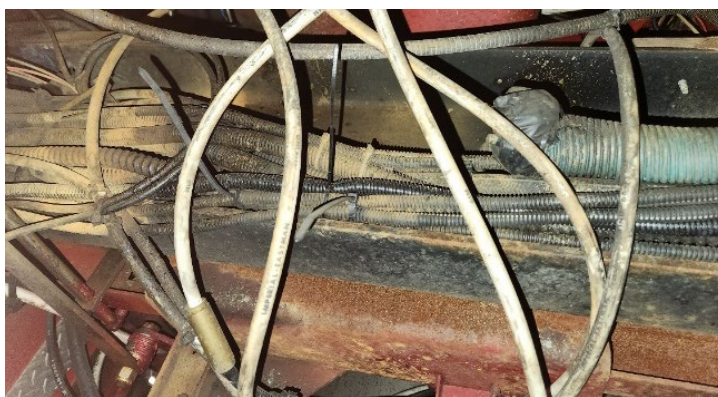
The frame rails on Engine 14-2 show their age with significant surface rust.

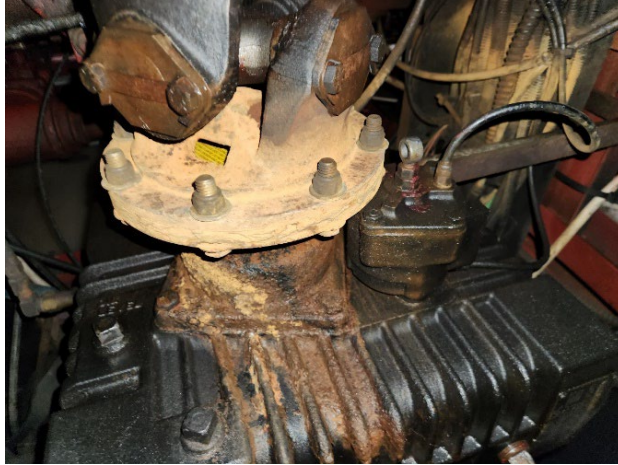
The pump packing on Engine 14-2 is leaking.

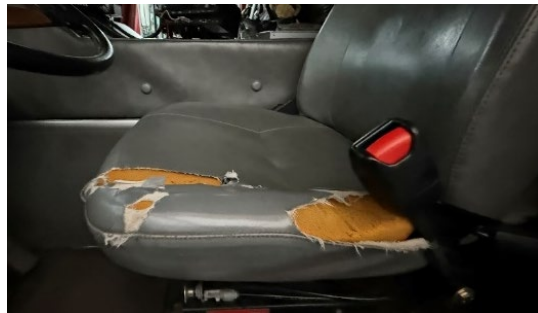
The driver's and officer's seats both need to be repaired.

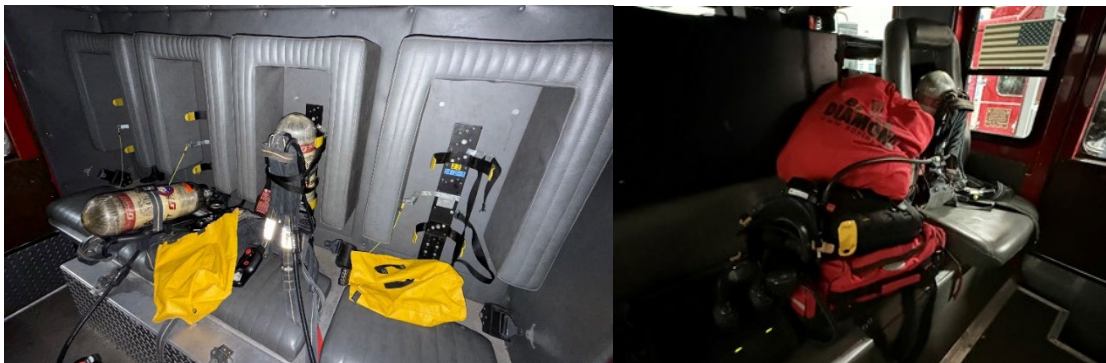
This unstrained SCBA and equipment could injure or kill a firefighter in the crew cab area during an apparatus rollover. SCBA and all equipment need to be secured.

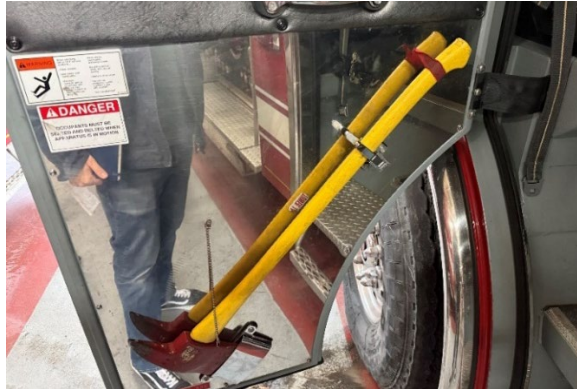
This axe and bracket should be removed to remove weight, and the bracket is not an NFPA-approved 9G Bracket.

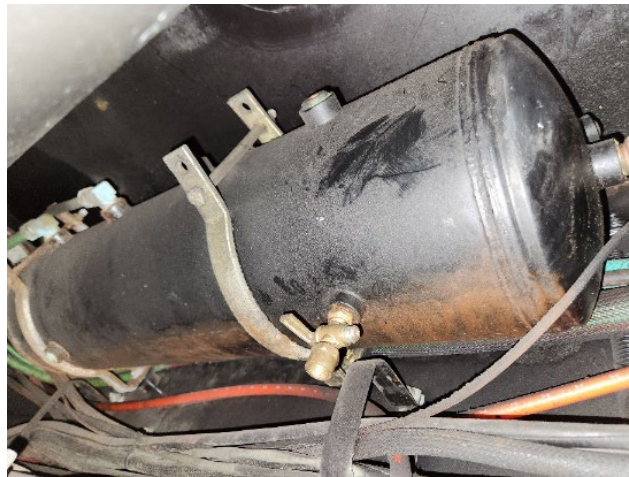
Moderate rust and corrosion are starting to form on the underside of the chassis.

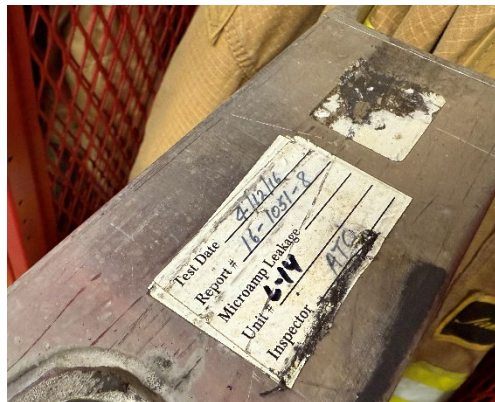
All portable ladders, hose, nozzles, fire pumps, and aerial devices need to be tested annually.

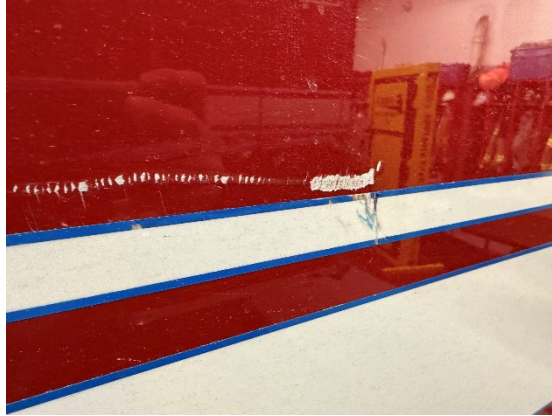
This paint damage needs to be repaired.

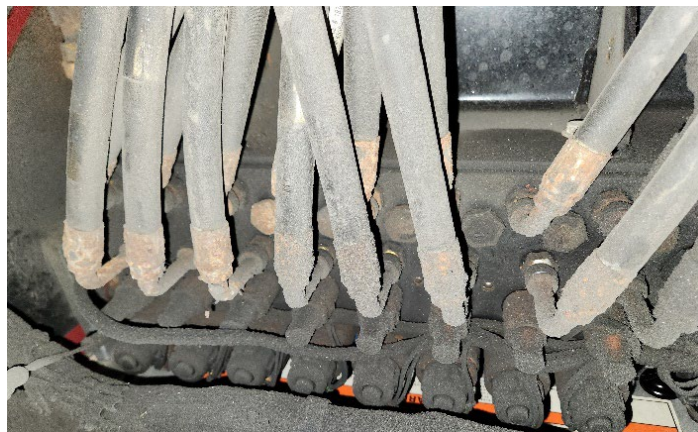
Moderate rust was noted throughout the underside of the apparatus, which needs to be mitigated.

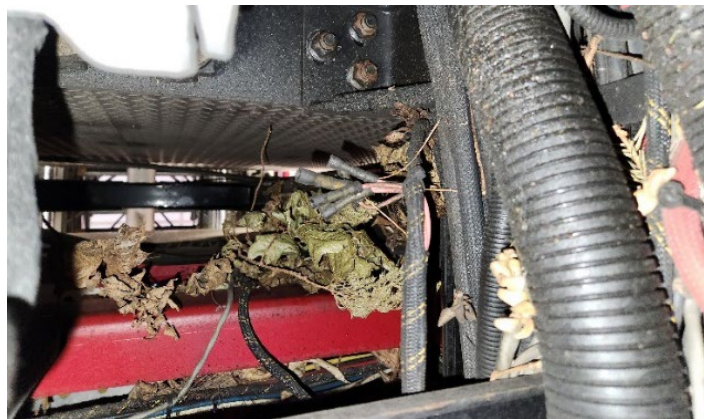
A large number of leaves and debris have caught under the underside of the apparatus, which requires thorough steam cleaning.

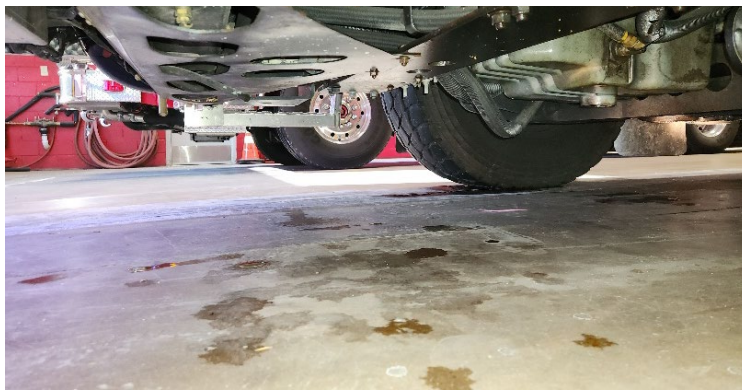
The Fluid leak needs to be evaluated.

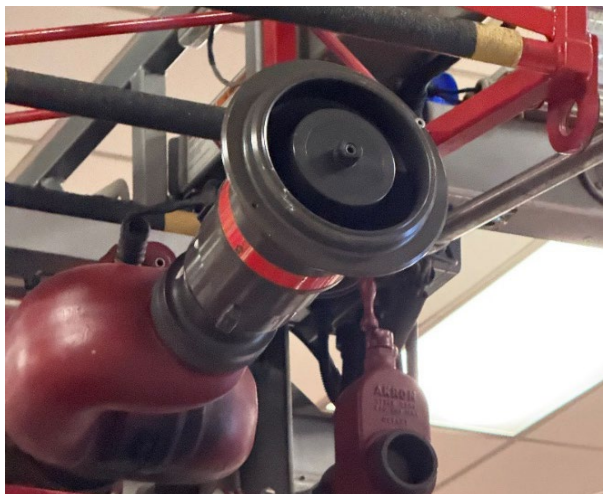
The combination nozzle should be removed and replaced with a set of stacked smoothbore tips with a stream shaper.

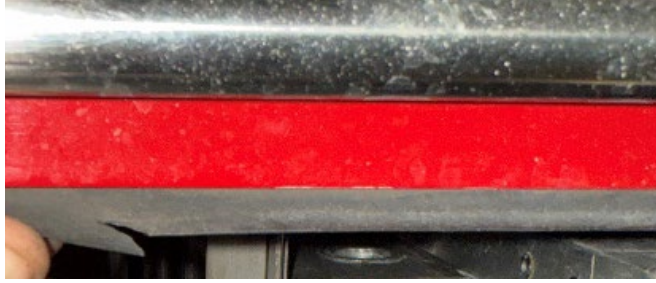
Replace the rubber gasket on the Goretite roll-up door.

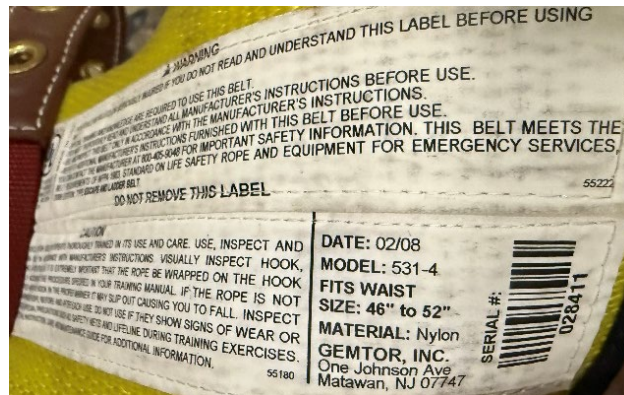
The ladder belts are expired. They need to be replaced when they are ten years old.

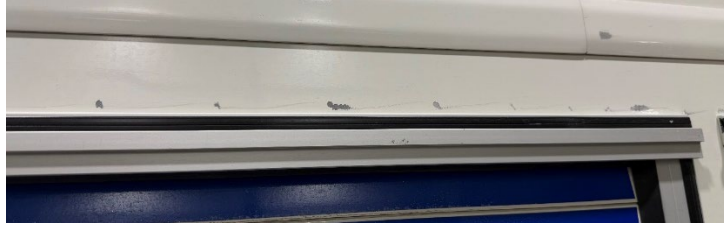
Chipped paint can allow rust to form on the body, causing damage.

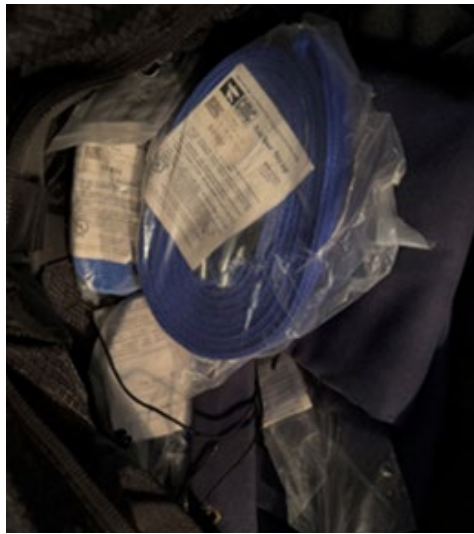
Unopened gear is not ready for service.

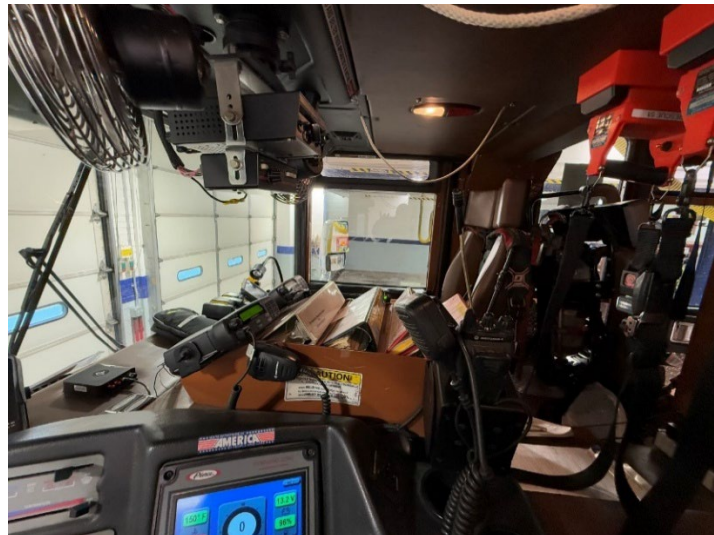
Mounting items such as fans and radios in the driver's sight line is hazardous and should be avoided.

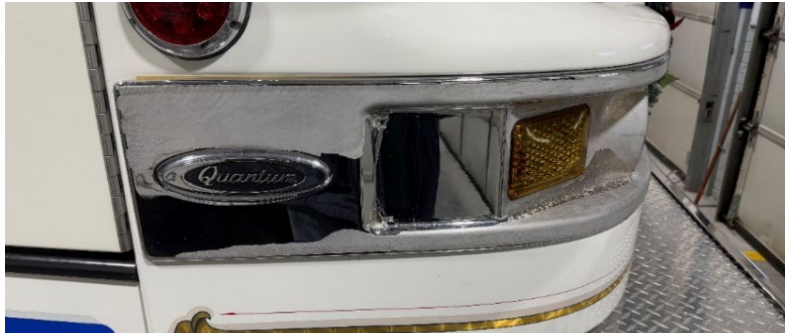
Chrome delamination needs to be addressed.

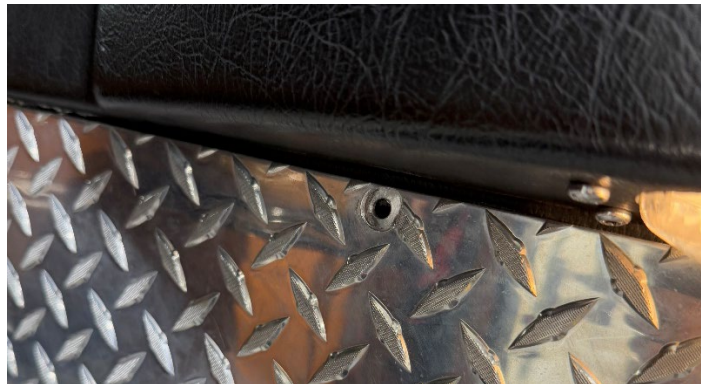
Areas were noted to be missing screws. These areas need to be identified and repaired.

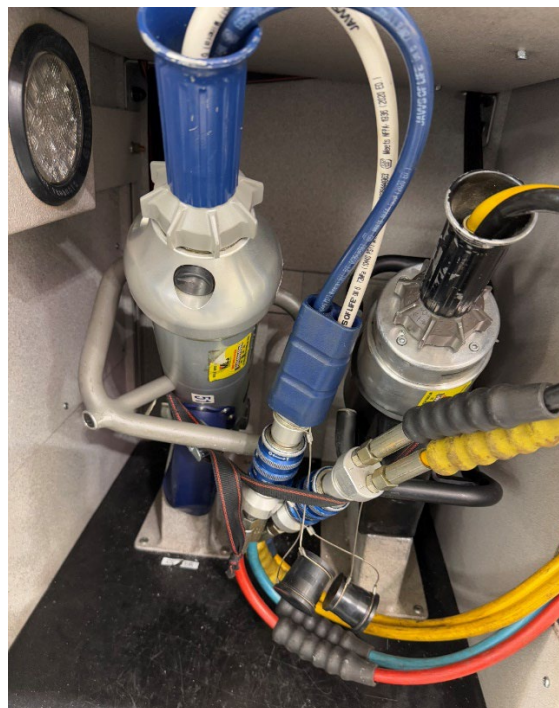
The strap does not allow for tools to be easily deployed on an incident.

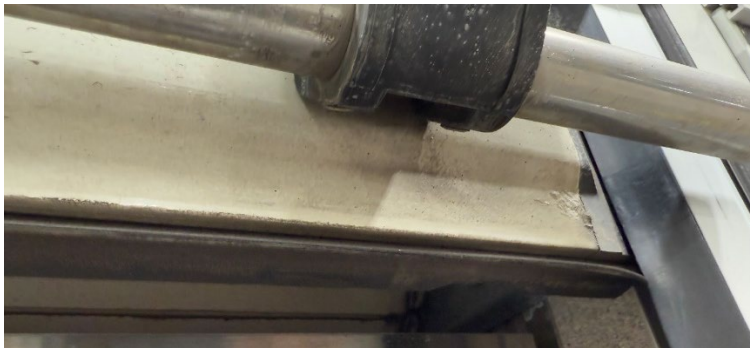
The damaged seals on the doors need to be replaced.

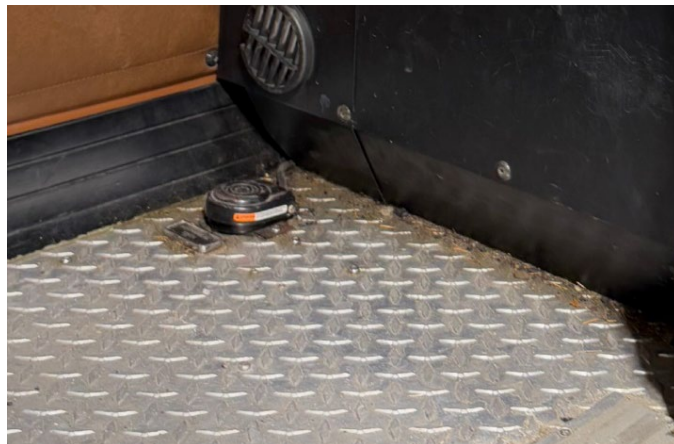
The Cab is dirty and should be cleaned.
