Tributary Investigation: Ridley Creek Tributary (Glen Rd. and Brent Dr.)

Nether Providence Township
83250-115MS4

Tributary Investigation: Ridley Creek Tributary (Providence Road)

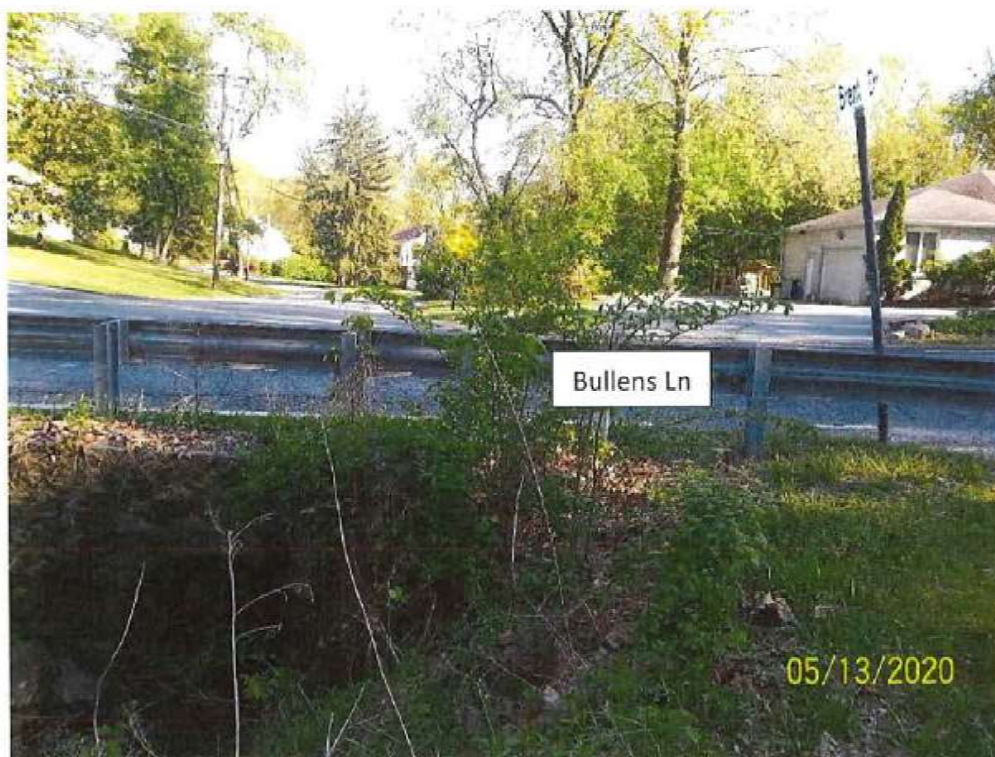
Figure 2. Culvert under Bullens Lane where the Ridley Creek Tributary (Brent Drive) crosses.

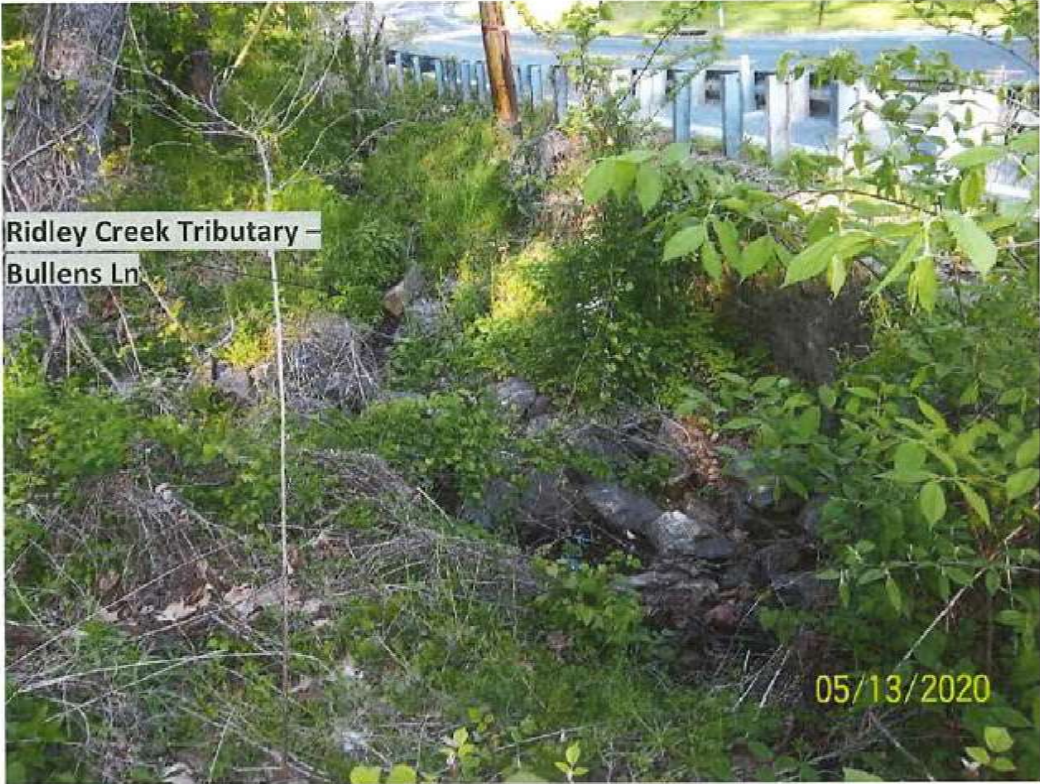
Figure 3. Another image where Ridley Creek Tributary (Bullens Ln) splits from the Ridley Creek Tributary (Brent Dr).

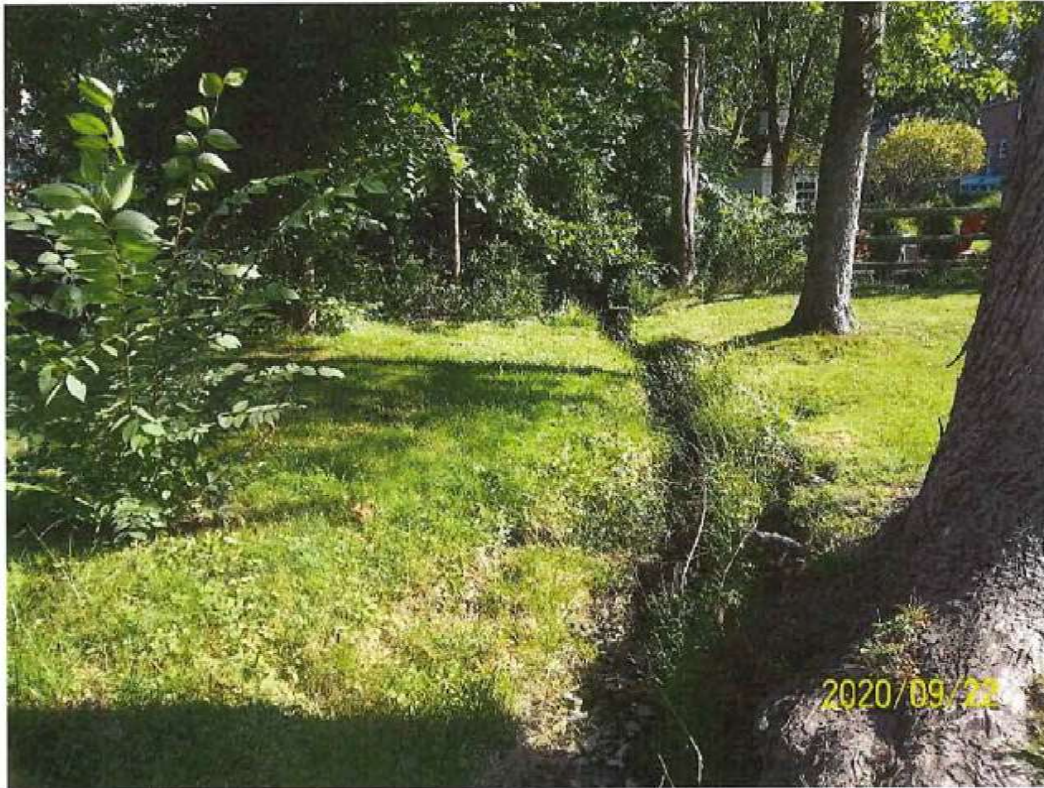
Figure 1. Dry Channel in the back of 418 Palmers Lane.

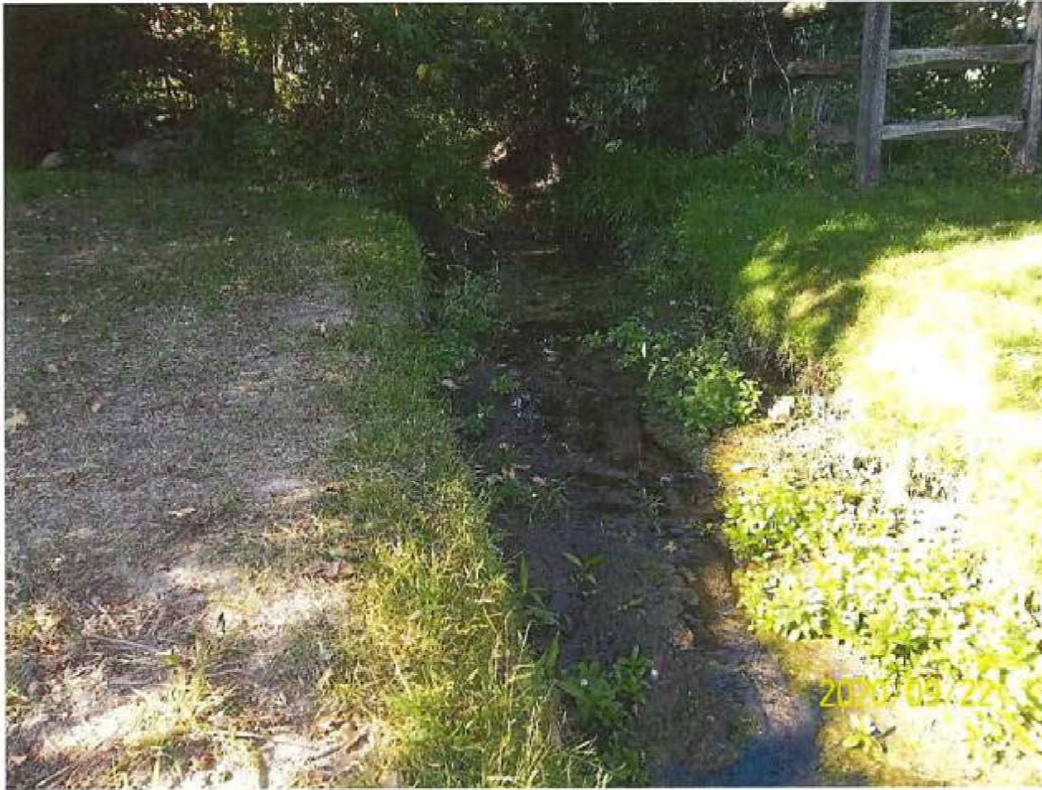
Figure 3. Water starting to flow between 418 and 420 Palmers Lane. Beginning of Tributary.

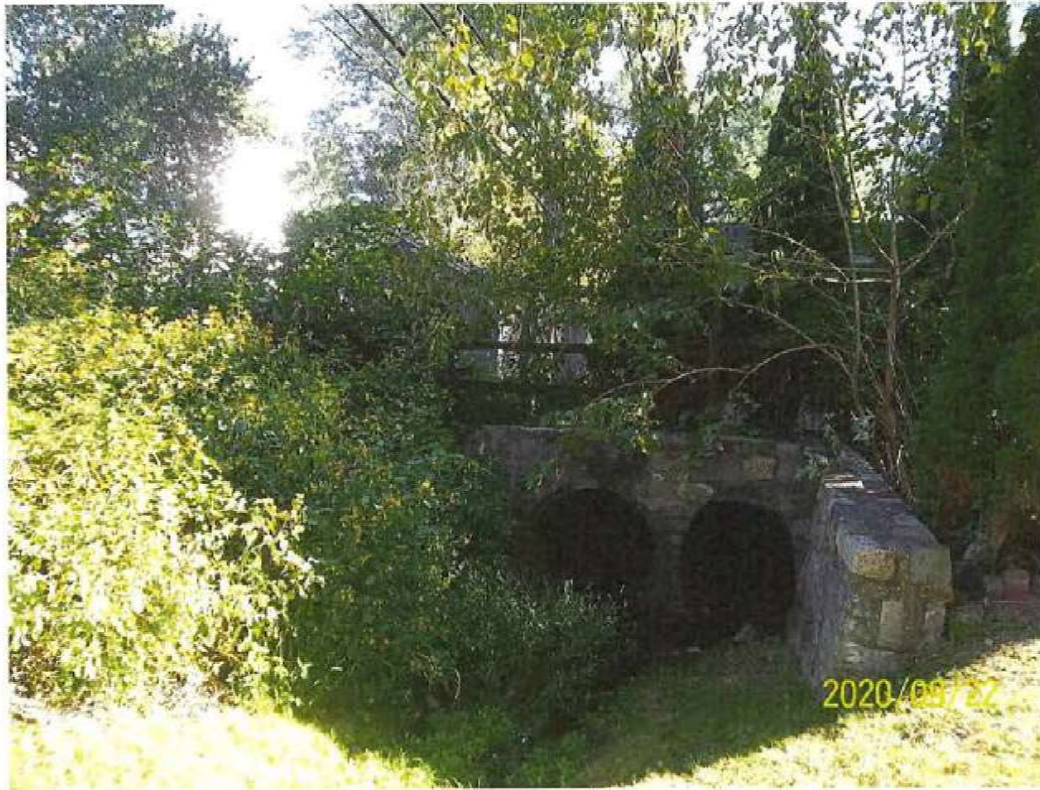
Figure 7. Headwall in the backyard of 428 Palmers Lane where tributary goes underground to cross East Rose Valley Road.

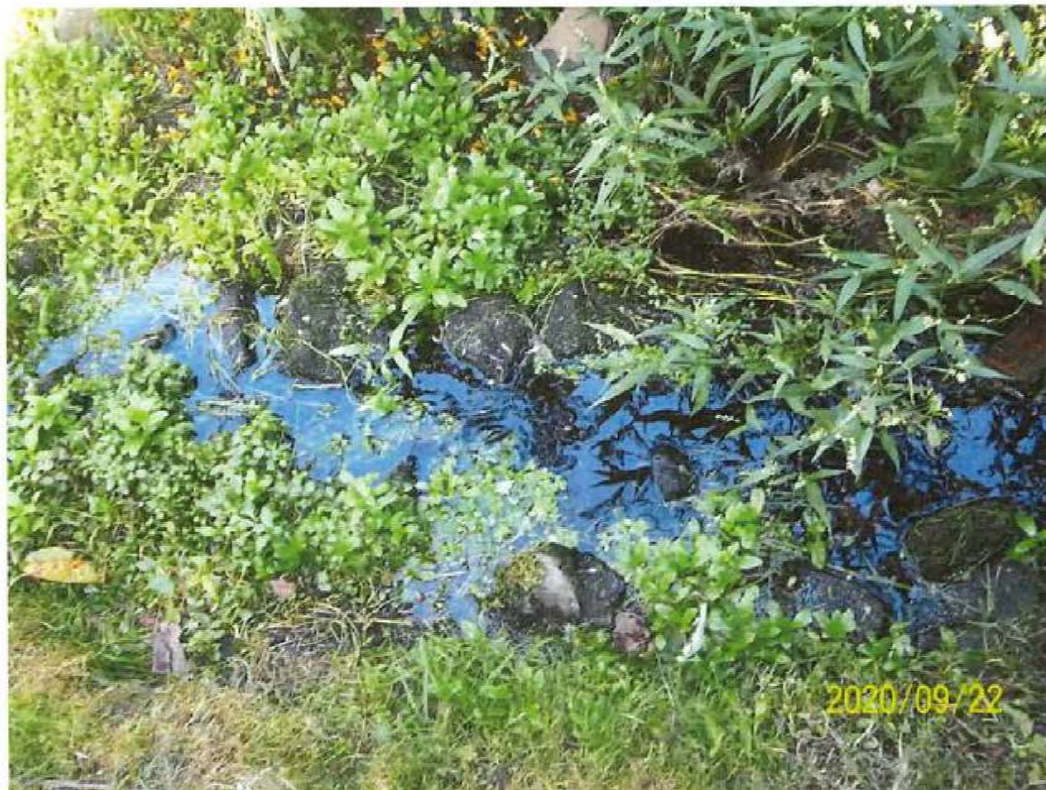
Figure 8. Flowing water still present before tributary goes into headwall.
