Nether Providence Township and Swarthmore Borough, PA.

**Swarthmore Fire and Protection Association Station 14
South Media Fire Company Station 51
Garden City Fire Company Station 65**

Fire Apparatus Fleet Review and Assessment

March 2025

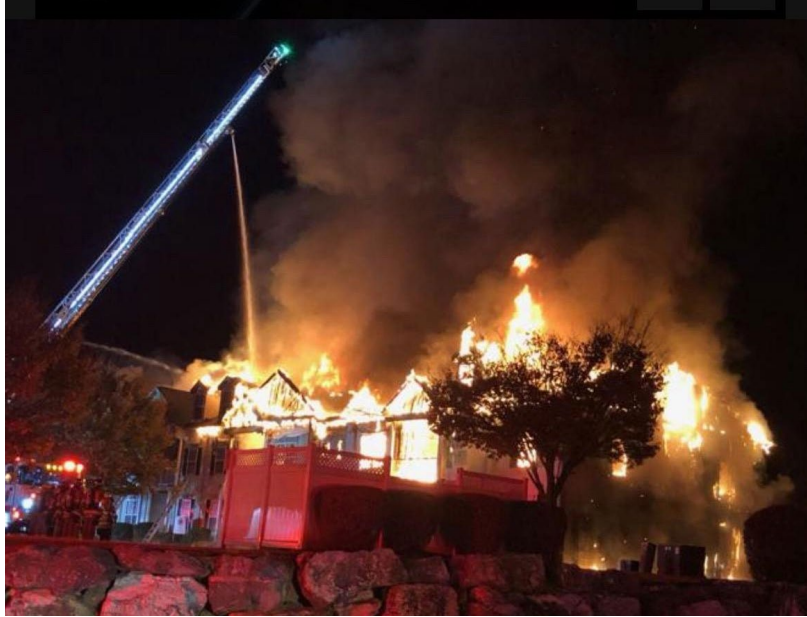
This apartment building fire in November of 2024 in Litz Pa. was equipped with the same sprinklers that are prevalent in apartment buildings throughout Nether Providence Township and Swarthmore Borough. Some residents were hurt and barely escaped with their lives. The township and borough must invest in a strong fire department and not rely solely on fire sprinklers as their primary means of protection.

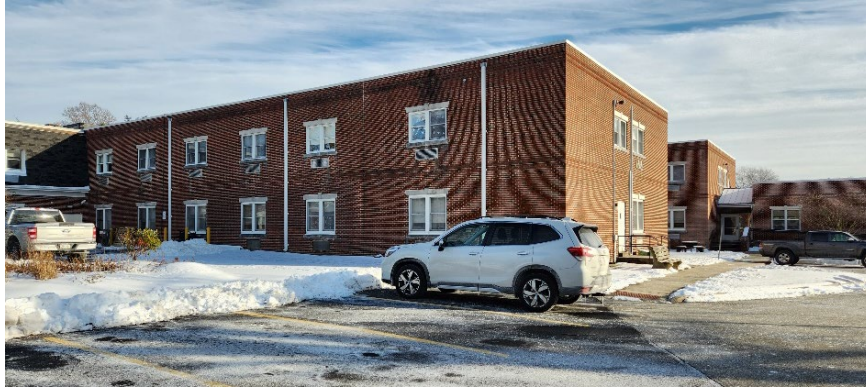
Older apartment buildings such as this building in South Media are not sprinklered and represent a serious fire problem and life safety risk.

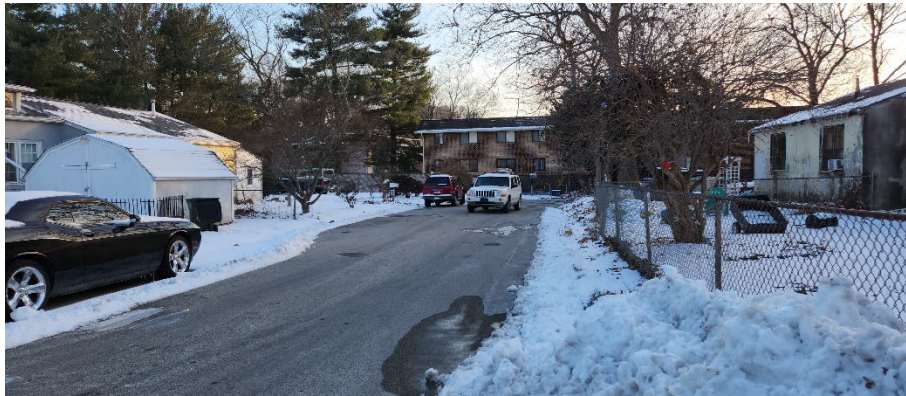
There may be a need for a tractor-drawn aerial ladder, given the numerous roads and access points in Garden City's first-due response area.

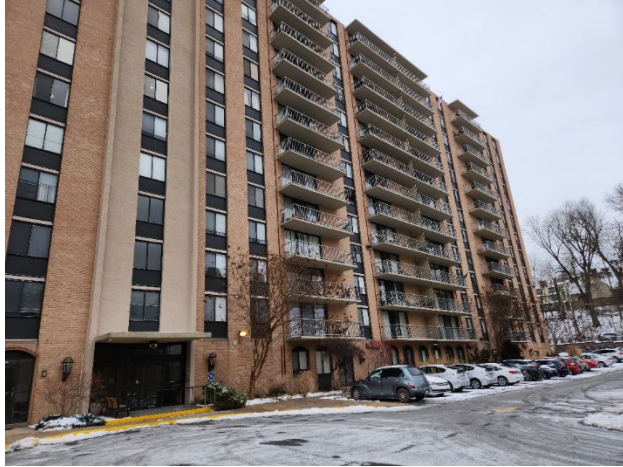
One of several high-rises that contain large civilian occupancies.

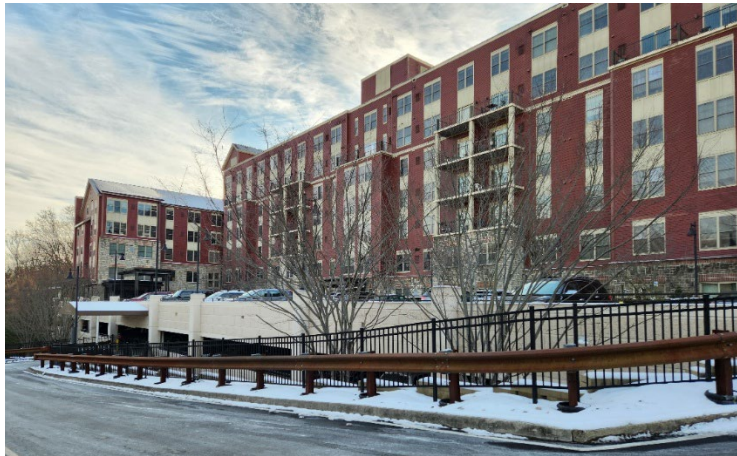
This building in South Meida represents another high-life safety risk.

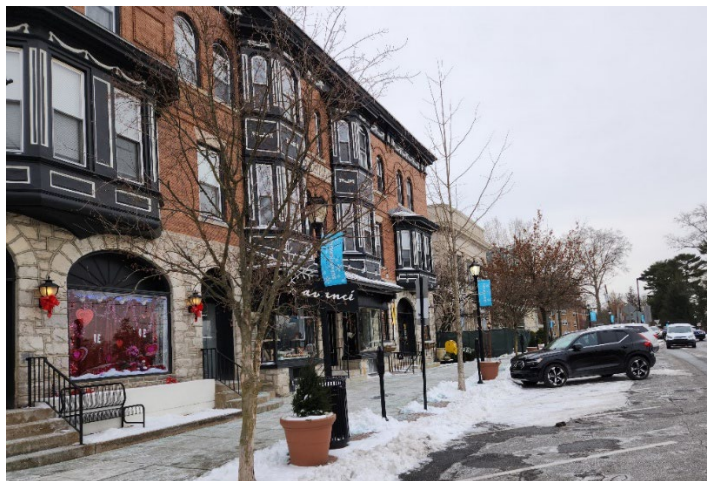
Connected buildings on the main street would necessitate a significant fire department response, including adequate staffing, large quantities of water, and a substantial number of portable ladders.

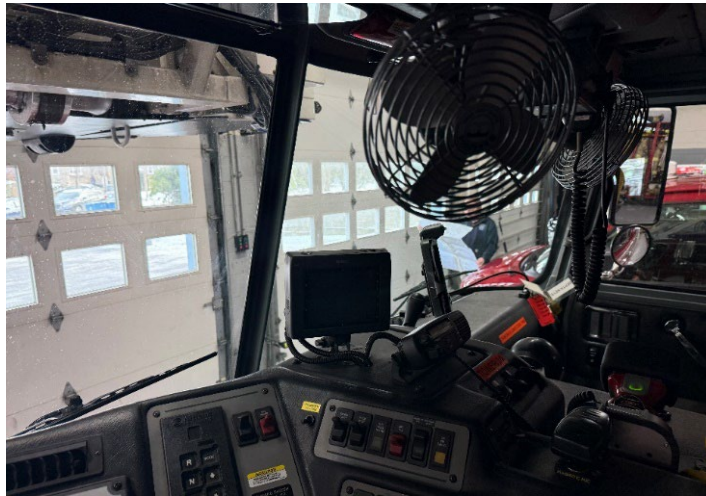
The driver's vision is obscured.

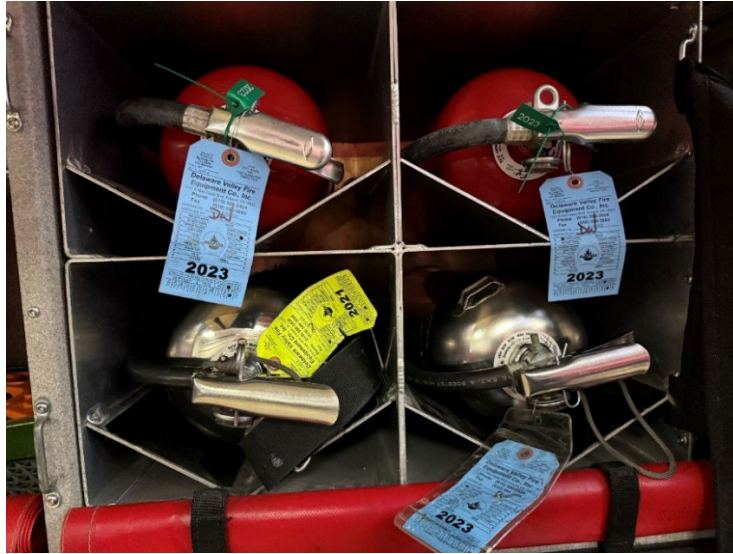
Fire Extinguishers are out of date and need to be recertified.
